# Arboricultural Impact Assessment

Roath Flood Risk Management Scheme  
Roath Brook  
Cardiff

Report Date: 27<sup>th</sup> November 2017

Project no: 624

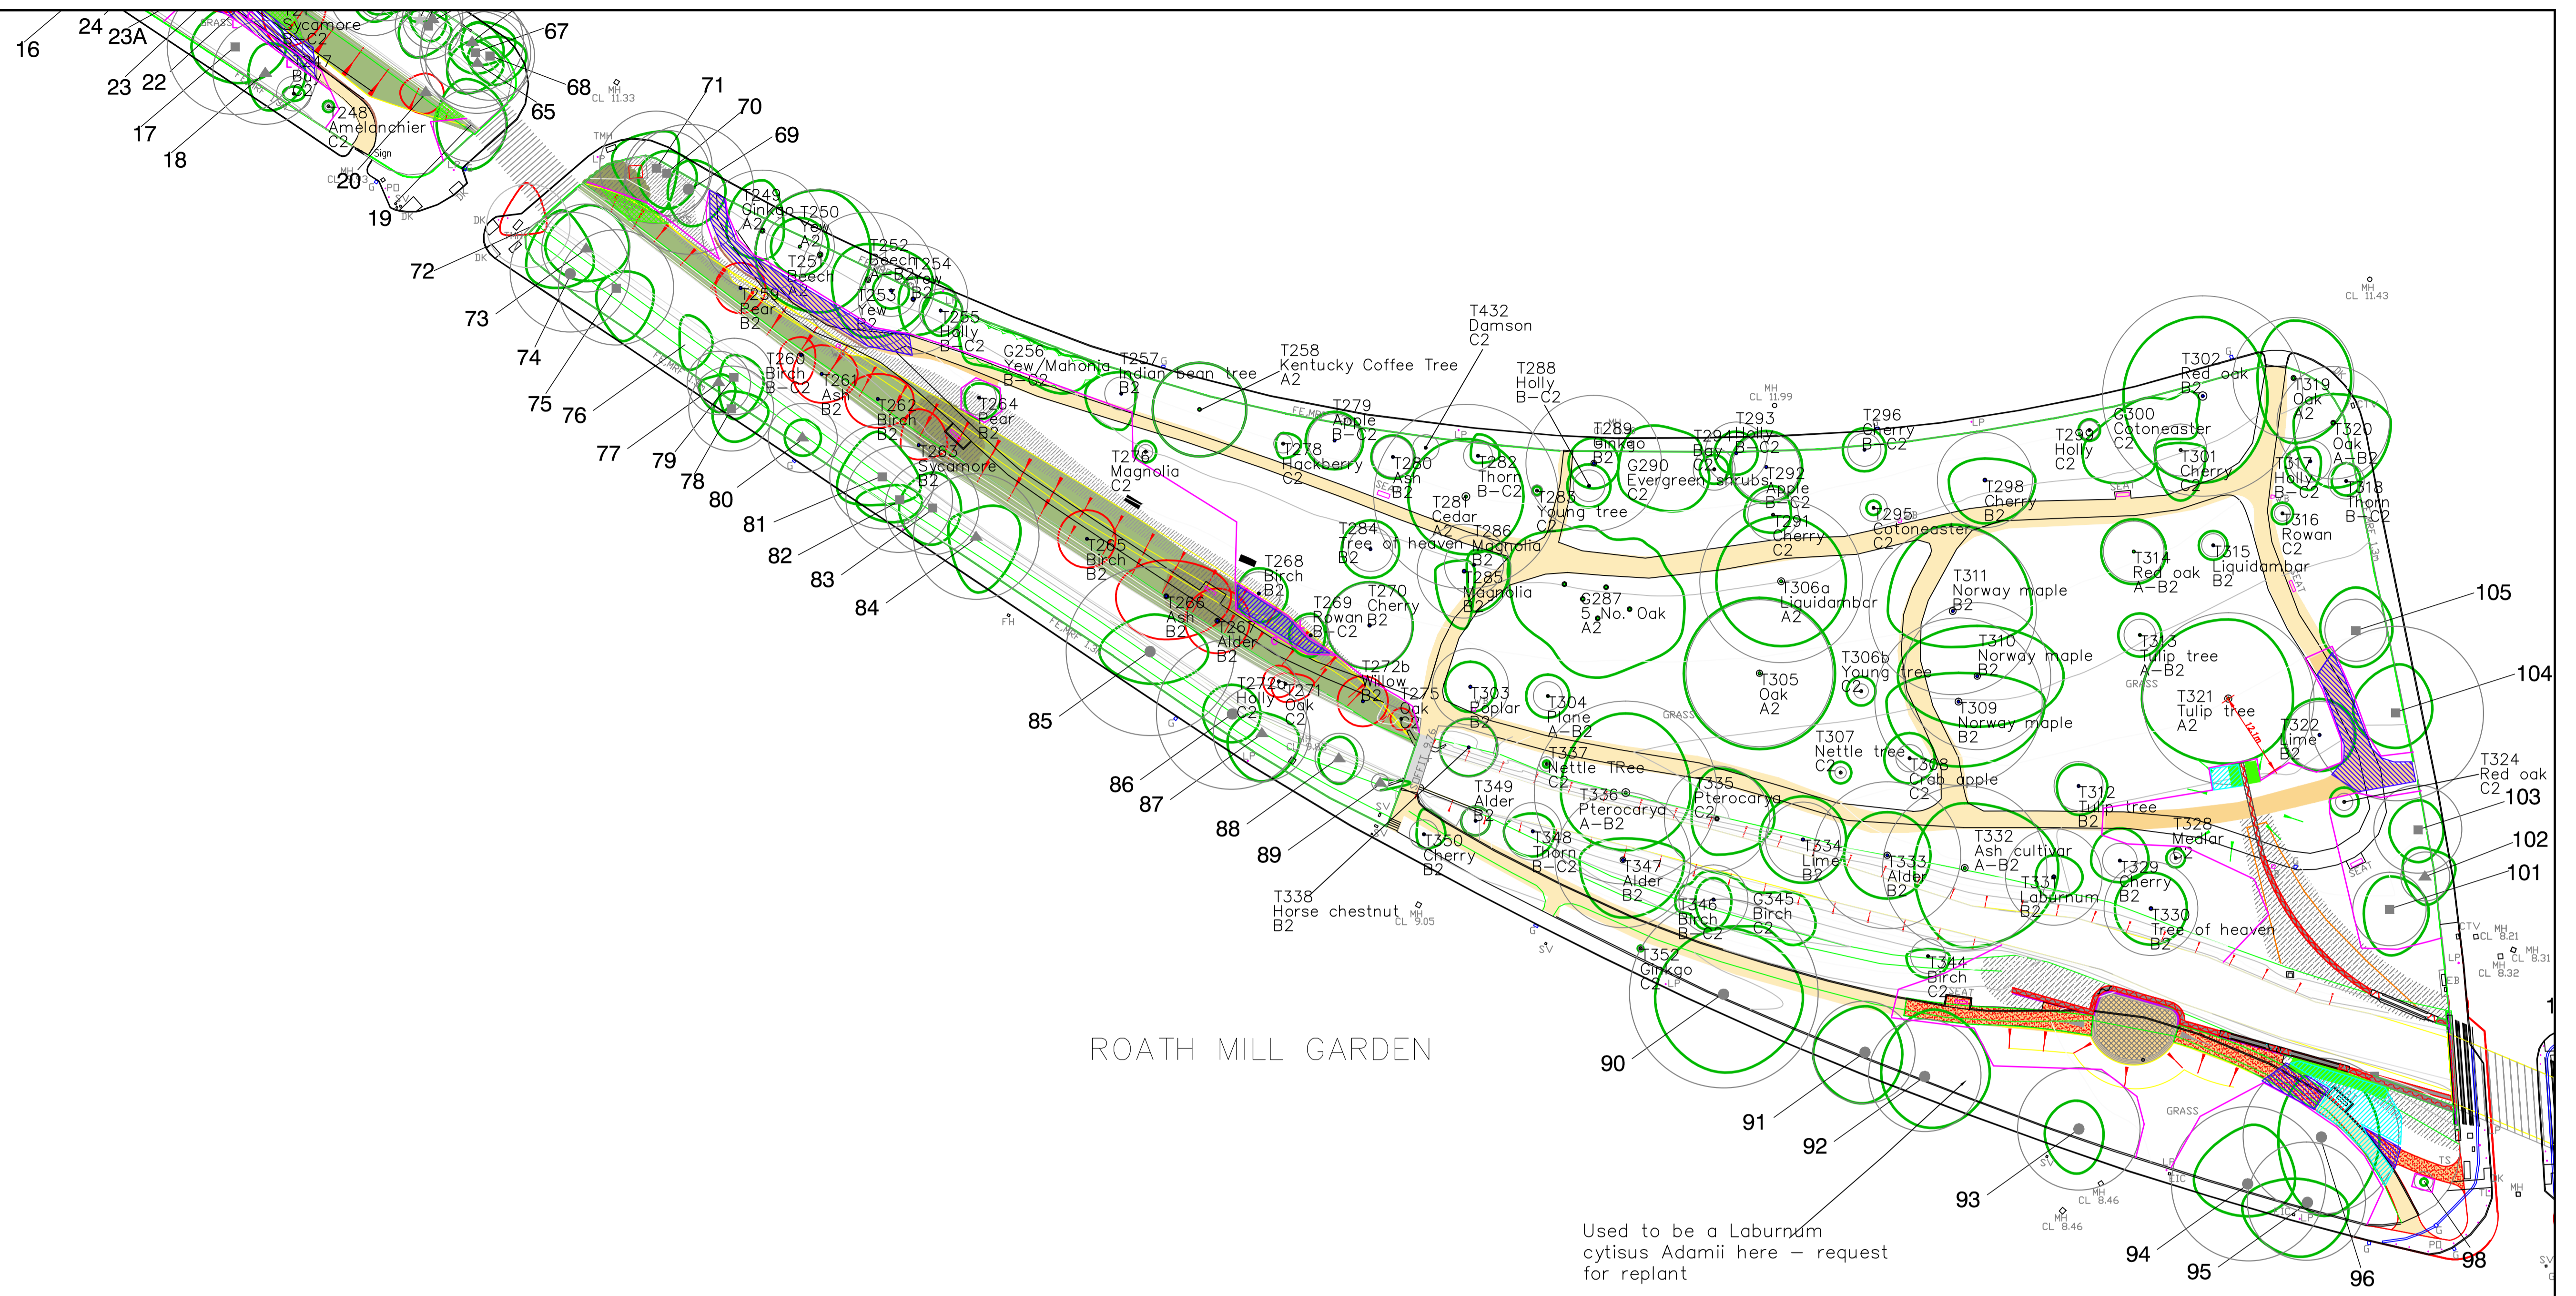
ROATH MILL GARDEN

Used to be a Laburnum cytiscus Adamii here – request for replant

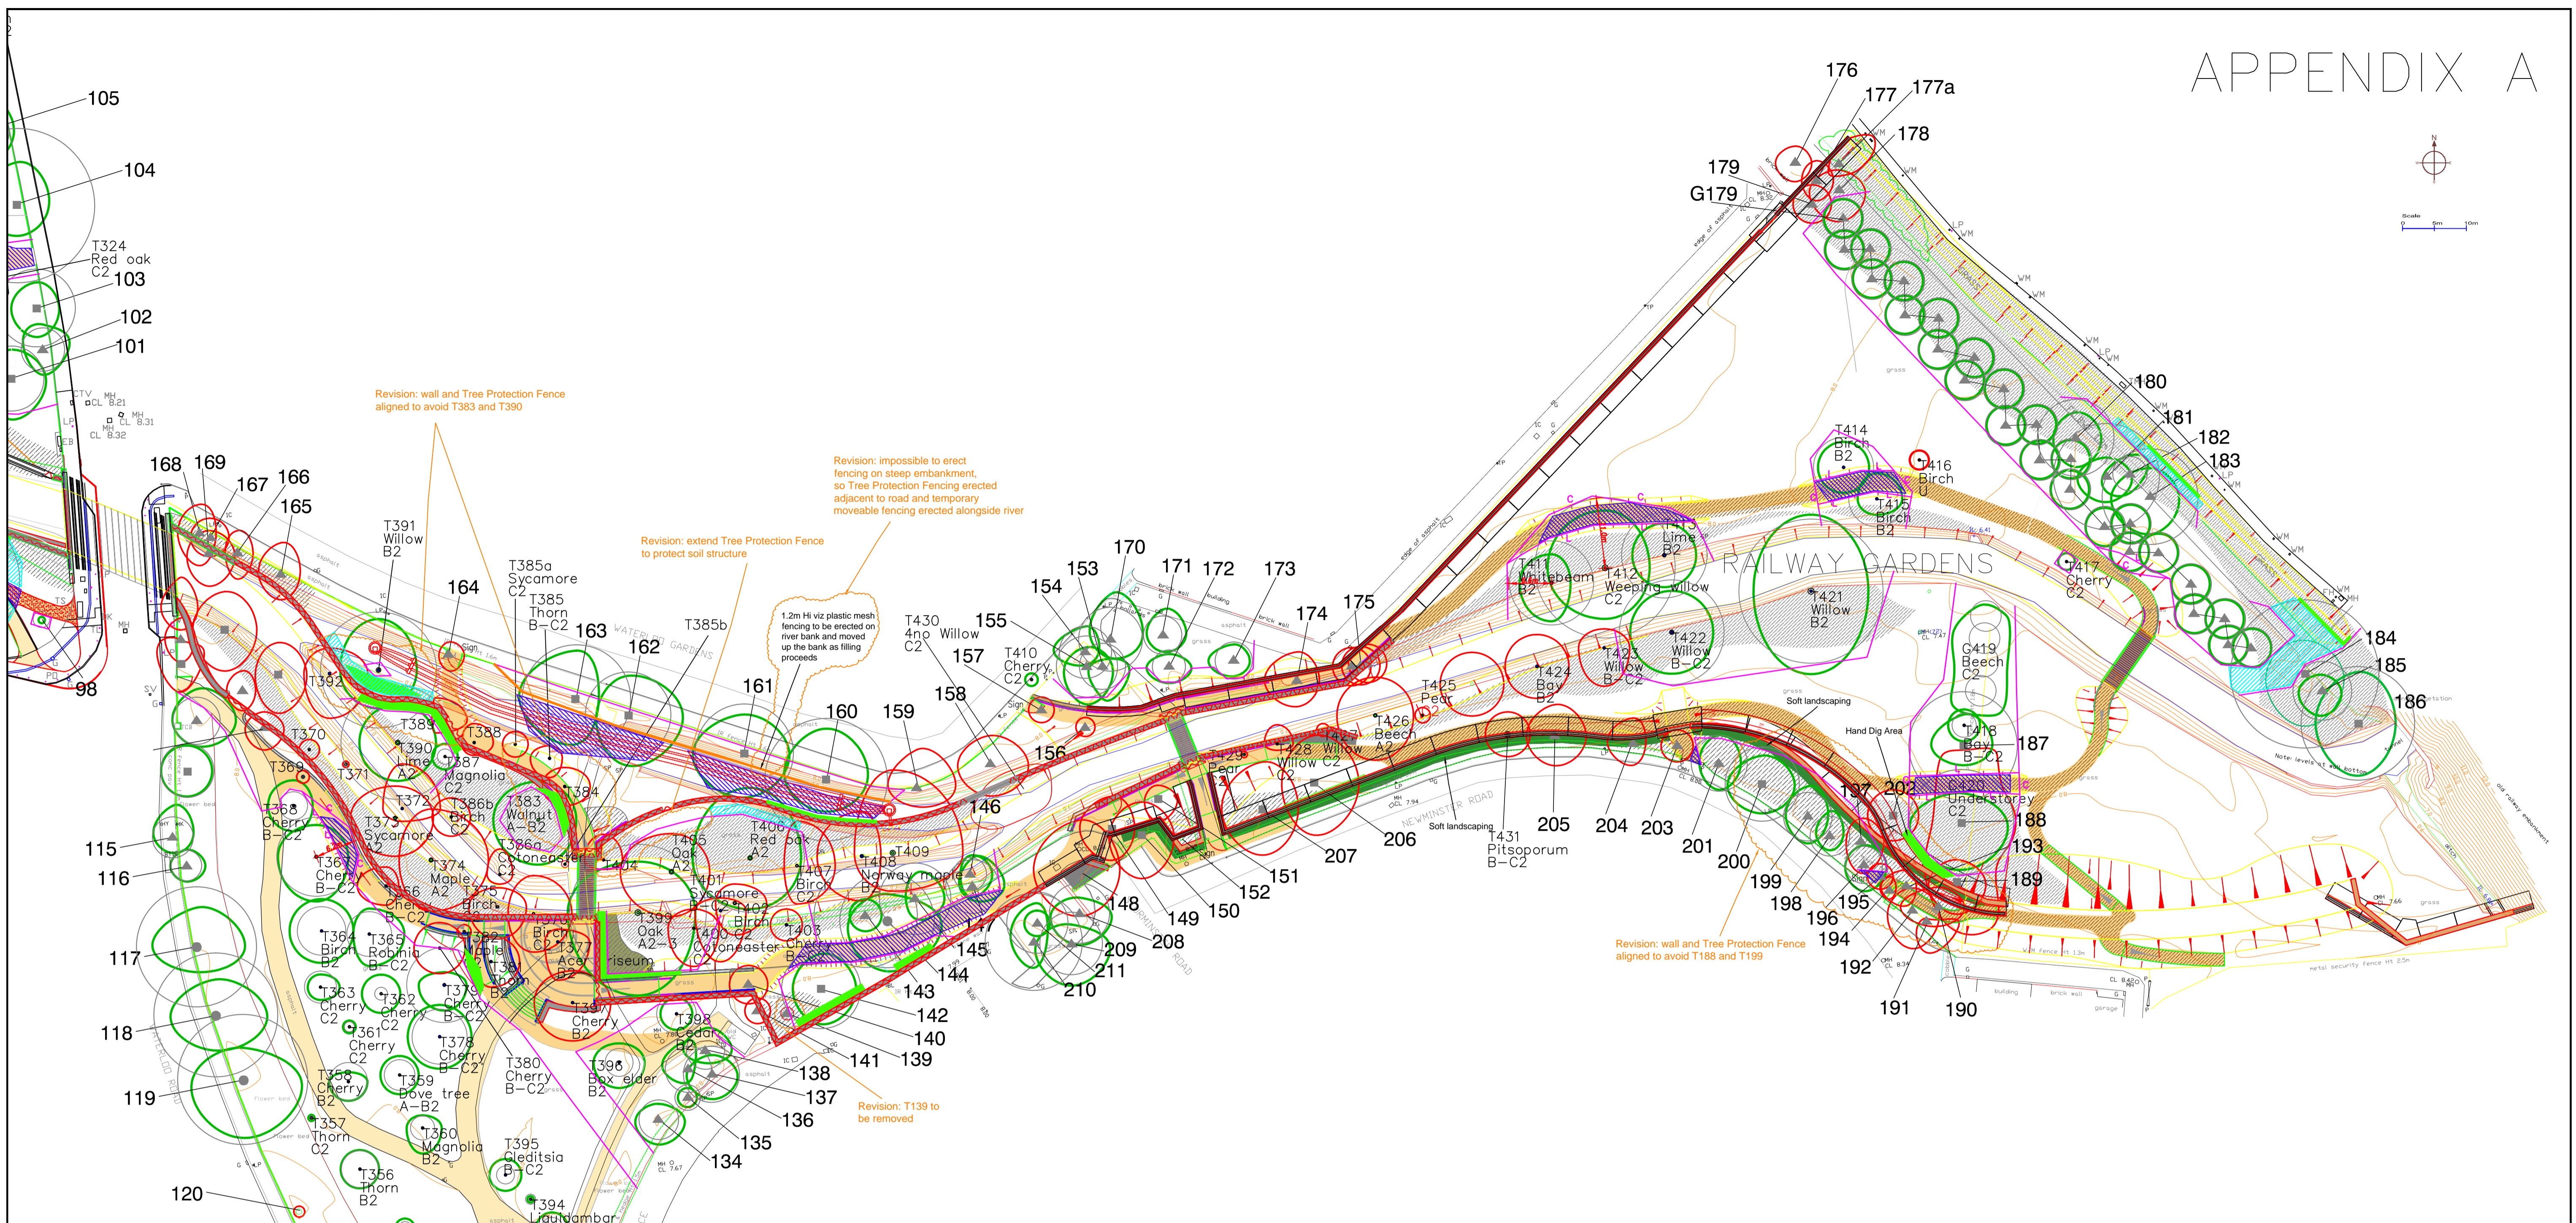
Revision: wall and Tree Protection Fence aligned to avoid T383 and T390

Revision: impossible to erect fencing on steep embankment, so Tree Protection Fencing erected adjacent to road and temporary moveable fencing erected alongside river
