# Welsh Coastal Storms, December 2013 & January 2014 – an assessment of environmental change

Natural Resources Wales Evidence Report No. 33  
July 2014

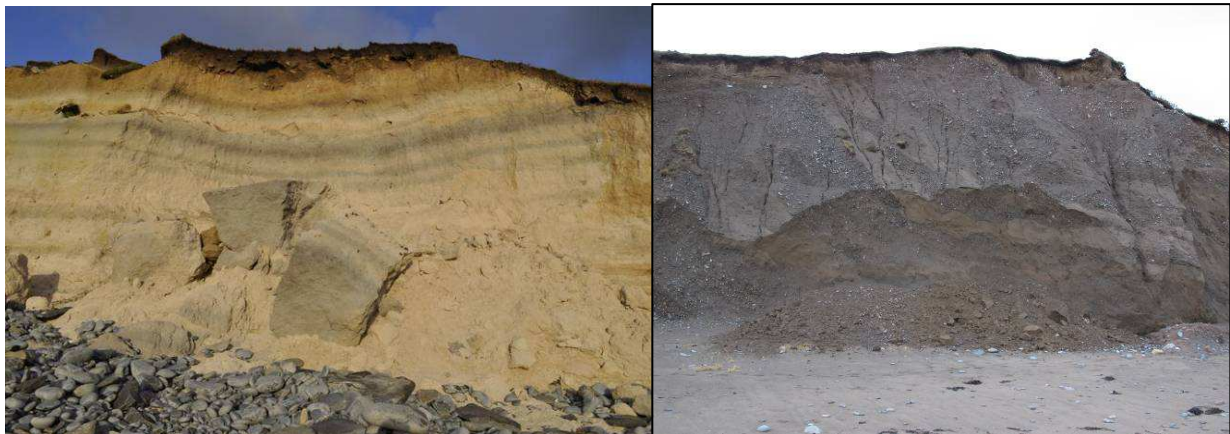
Figure 3. Collapsed tufa at Cwm Nash, Vale of Glamorgan showing an example of a 'finite' geological deposit (Chris Byrne Natural Resources Wales, 9th Jan 2014) & 'freshened' Quaternary exposures at Dinas Dinlle already showing signs of slumping (Raymond Roberts, Natural Resources Wales, January 2014).

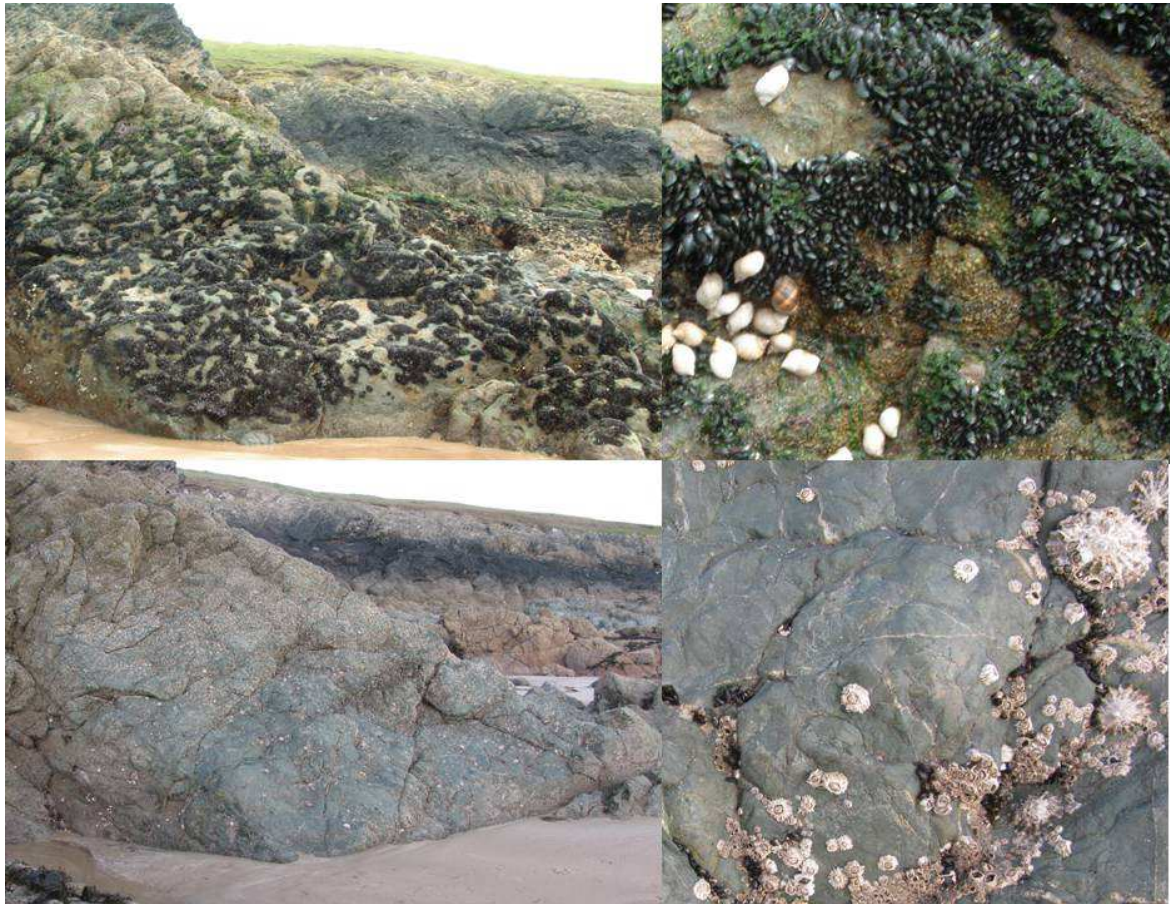
Figure 4. Rocky Shore at Aberffraw- before photos at top, after at the bottom, showing loss of mussels and dogwhelks and a reduction in barnacles (Photo provided by Ivor Rees).

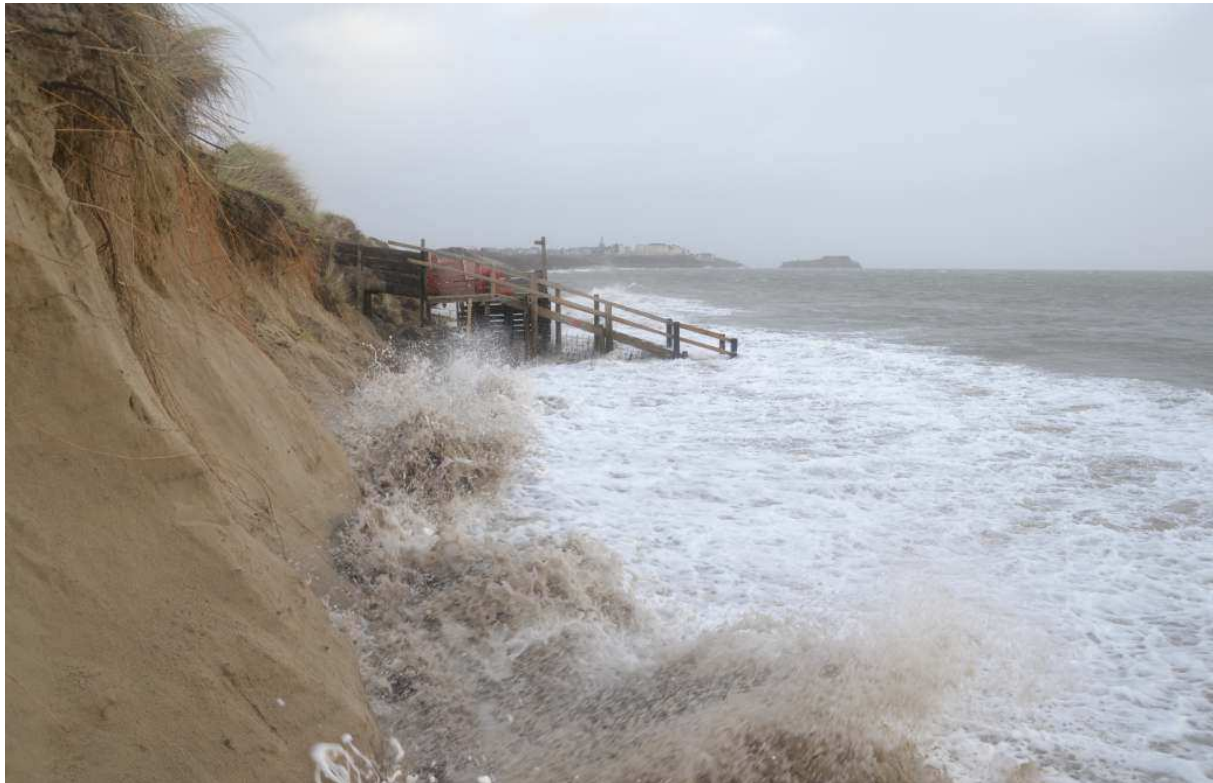
Frontal sand dunes and soft cliff were severely affected due to erosion, causing slumping and breaching at a number of locations and exposing bedrocks and clay deposits at some sites (Figure 5). These changes may have had a significant impact on populations of rare or threatened invertebrates such as the Strandline Beetle *Eurynebria complanata* and the Large Mason Bee *Osmia xanthomelana* which are present in a restricted number of localities in Wales. Subsequent monitoring has shown that *O. xanthomelana* has survived the storm events at its two Welsh localities, but in much reduced numbers (see 8.1.3 In Annex 1).

Figure 5. Erosion of the dunes in action at Penally on 6th January 2014 (Sid Howells, Natural Resources Wales).

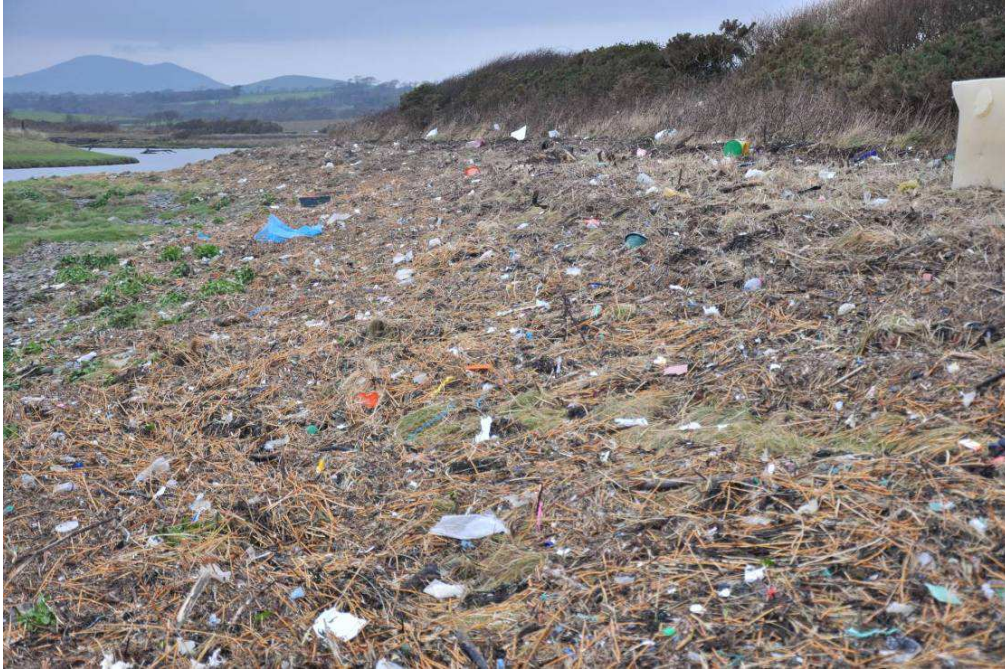
Significant volumes of litter were deposited on the shore and further inland during the storm events ranging from small polystyrene beads and plastic fragments, to large plastic boxes and fishing nets (Figure 6). Litter can also be trapped and buried within dunes, and therefore may have been released through dune erosion. It is accepted that litter can cause harm to marine wildlife through entanglement and ingestion, and through movement across and smothering of the seabed. Fishing related debris was noted as a significant component of the 'litter' washed ashore. The fishing industry lost a significant amount of fishing gear at sea during the storms. As a result, Welsh Government has made compensation available to enable gear to be replaced. There is therefore a potential opportunity to assess the scale of this issue through assessing the compensation claims submitted.

Figure 6. Strand of litter at Afon Dwyfor (Paul Brazier, Natural Resources Wales, 12<sup>th</sup> Jan 2014)

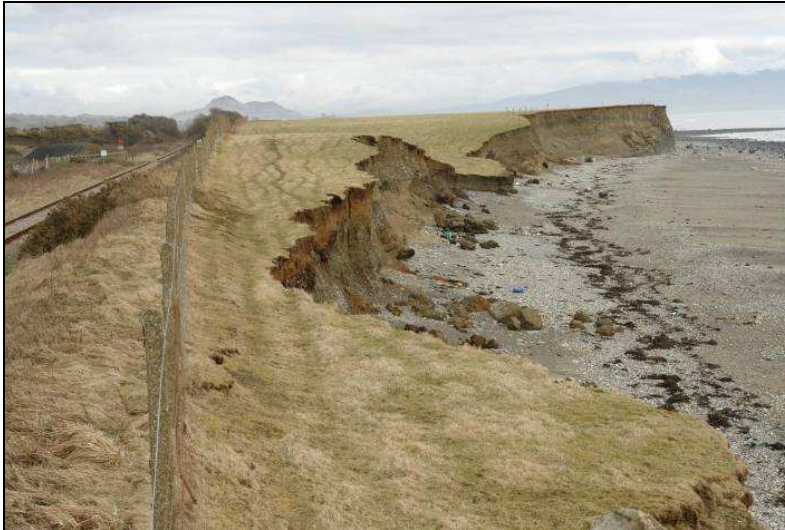
Many Quaternary sites contain areas of glacial sands and gravels that are particularly susceptible to coastal erosion. The GCR site at Glanllynau on the Llŷn Peninsula has two individual components separated by a mainline railway. The coastal cliffs comprise glacial, late-glacial and Holocene sediments while inland of the railway a landform assemblage comprises kettle holes and associated sediments. Both features require different management. The coastal 'exposure' feature needs to be kept visible and accessible and is kept fresh by wave action. The morphology of the inland 'integrity' feature needs to be kept intact. The recent storms have caused significant erosion at the western end of the site (Figure 7) and there is likely to be discussion on what measures are needed to protect the railway. Rock armouring put in place to protect the railway has already begun to encroach on the GCR interest. At Abermawr in Pembrokeshire, there has been significant erosion of the Quaternary interest (Figure 8). Photo-monitoring by geologists from Natural Resources Wales helps gives a measure of the rate of coastal erosion and an example of the effect on a particular GCR feature.

Figure 7. Erosion at Glanllynau is likely to lead to casework with Network Rail (Stewart Campbell, Natural Resources Wales).

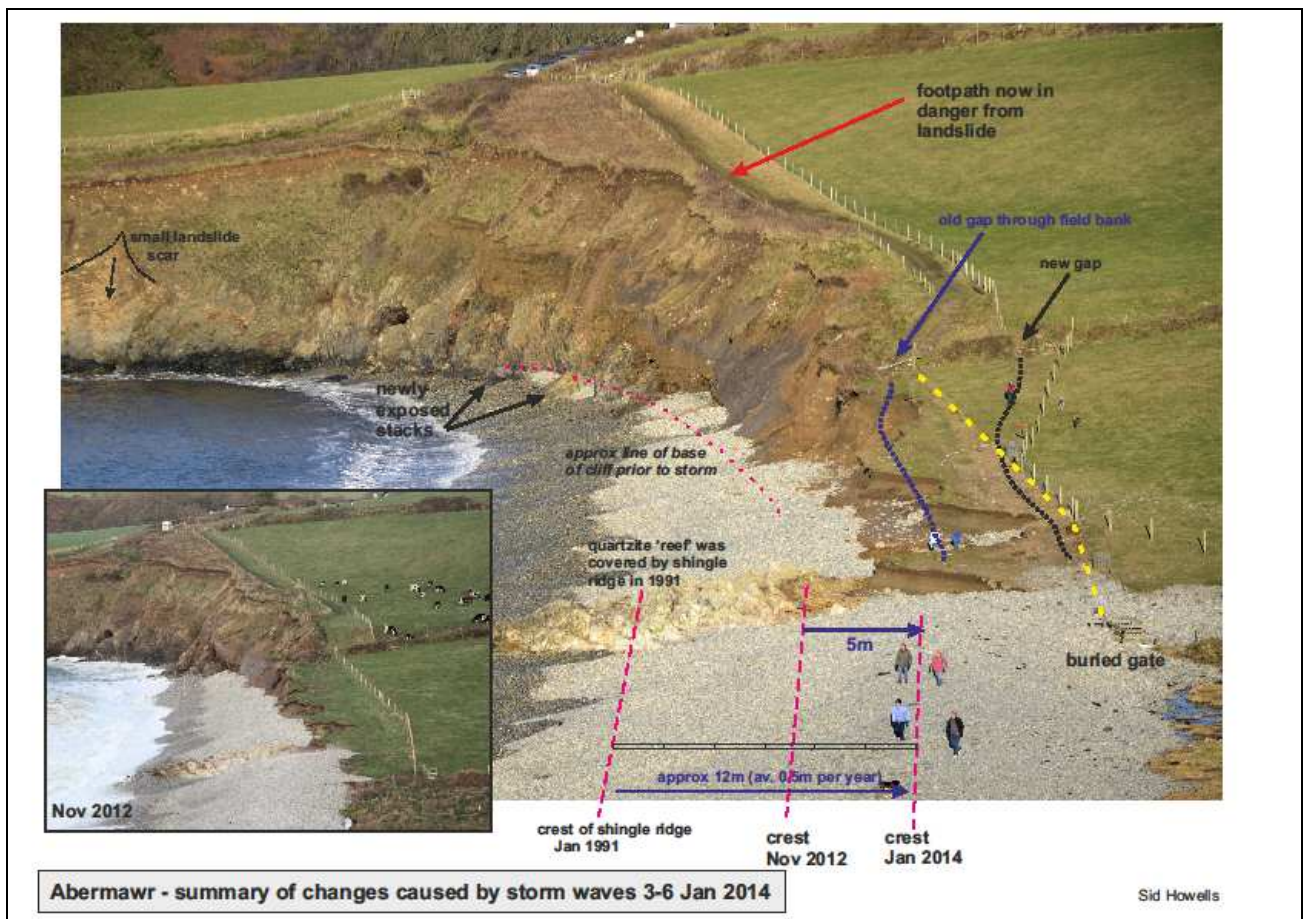
Figure 8. Erosion of Quaternary geological features at Abermawr, Pembrokeshire (Sid Howells, Natural Resources Wales).

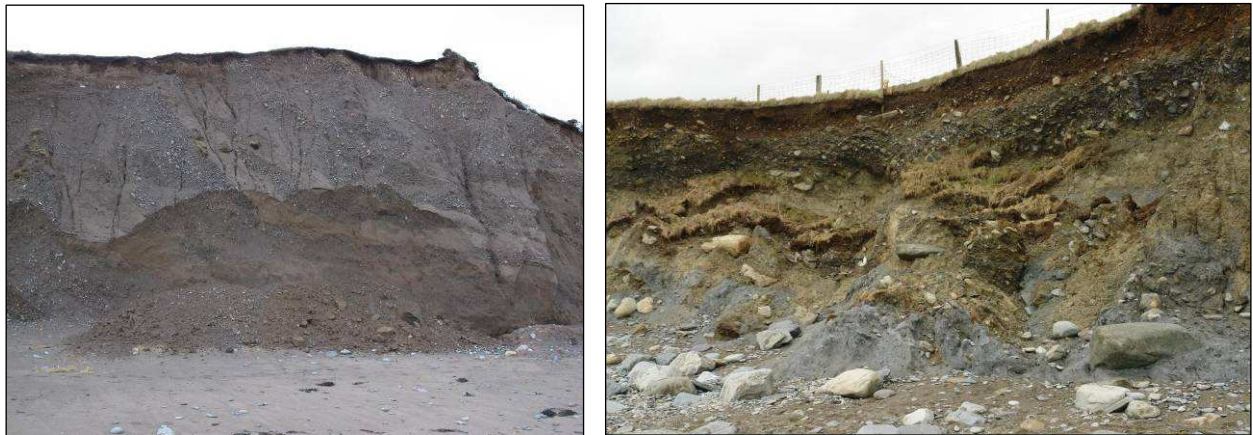
Dinlle, Moranedd (Figure 9) and Glanllynau. Although removal of the debris is beneficial to the site interest, this is often only for the short-term as many of these cliffs will slump again.

Figure 9. The susceptibility of Quaternary sites to erosion varies depending on the material. Dinas Dinlle (left) illustrates glacial sands and gravel and Moranedd (right) shows glacial till forming the lower part of the cliff.

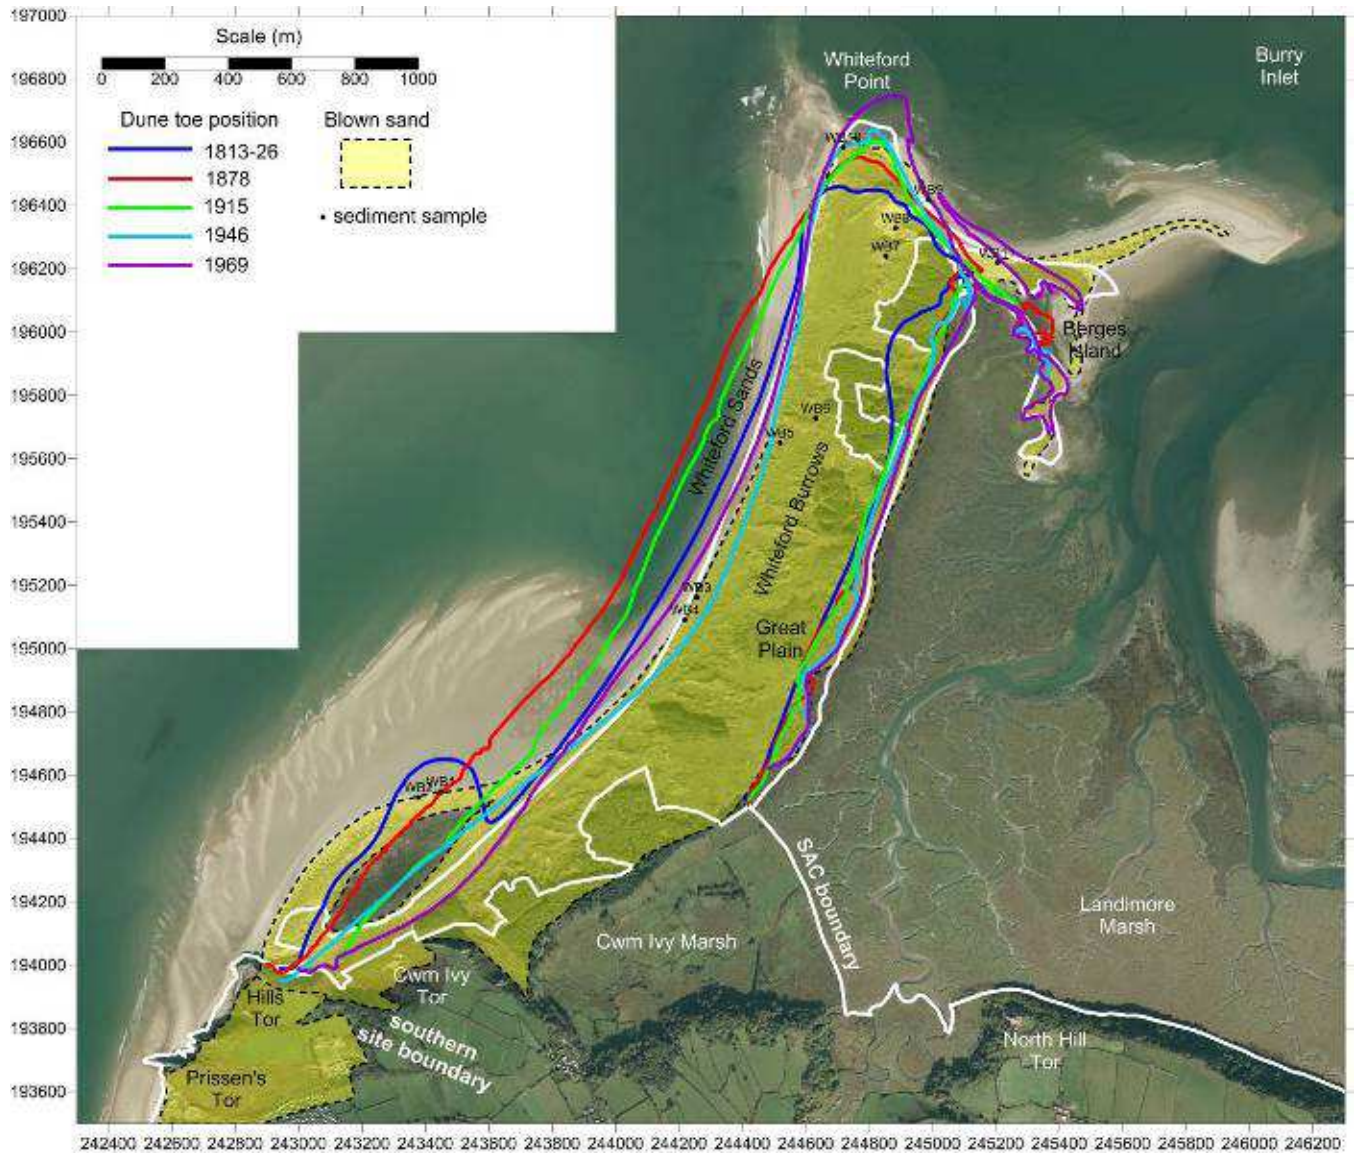
estimate, through expert geomorphological assessment, an erosion rate of approximately 70-100m by 2100, double that predicted in NCERM. The storm events of December 2013 and January 2014 resulted in the erosion of 10m along a significant length of dune frontage, with erosion up to 15-20 m in places. Whilst some recovery is expected, it is clear that these events were significant in the context of longer-term predicted change, and demonstrates the degree of dynamism which can be experienced at these sites.

Figure 10. The extent of blown sand in relation to SAC boundaries at Whiteford Burrows. Also shown are the positions of the dune toe inferred from historical maps and aerial photographs (from Pye & Blott 2012).

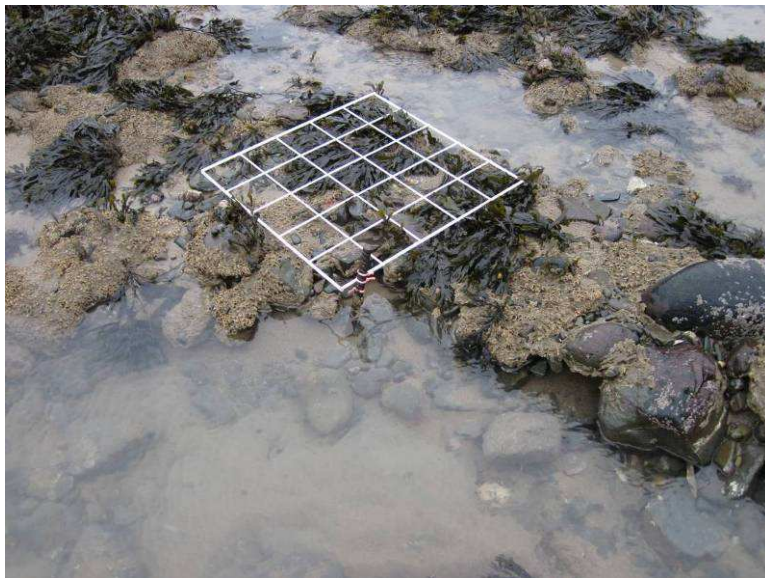
At a number of sites where Honeycomb reef (a Section 42 habitat and Special Area of Conservation [SAC] biogenic reef) covers the mid and lower shore (Criccieth, Cei Bach, Dunraven Bay), the sand that this worm relies on to form tubes has been removed from the shore, although the very high levels of suspended material resulting from the storm has so far been supplying the necessary material for tube rebuilding. The sustained biogenic reef will depend on the return of sand onto the beaches during the spring and summer in order to permit tube growth. In some locations, the wave action has broken holes into the reef forming rock mills which gradually widen the area of damage (Figure 11). High river levels can also compromise the resilience of the reef by applying physiological stress on individual worms (Figure 12).

Figure 11. Damage to the integrity of Honeycomb *Sabellaria alveolata* reef at Cei Bach (Paul Brazier, 31<sup>st</sup> Jan 2014).

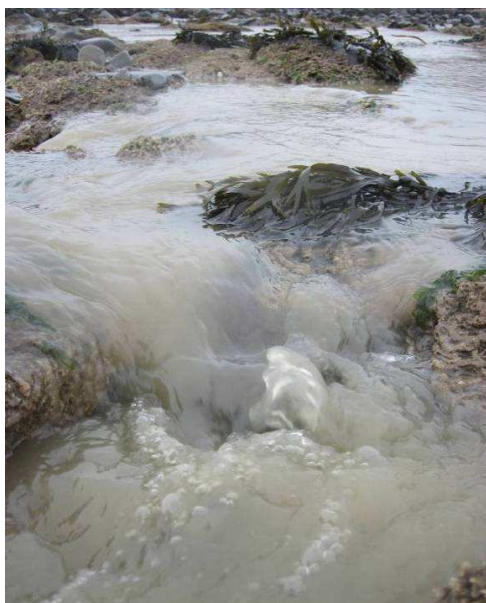
Figure 12. Flooding across the biogenic honeycomb reef at Cei Bach (Paul Brazier, 31<sup>st</sup> Jan 2014).

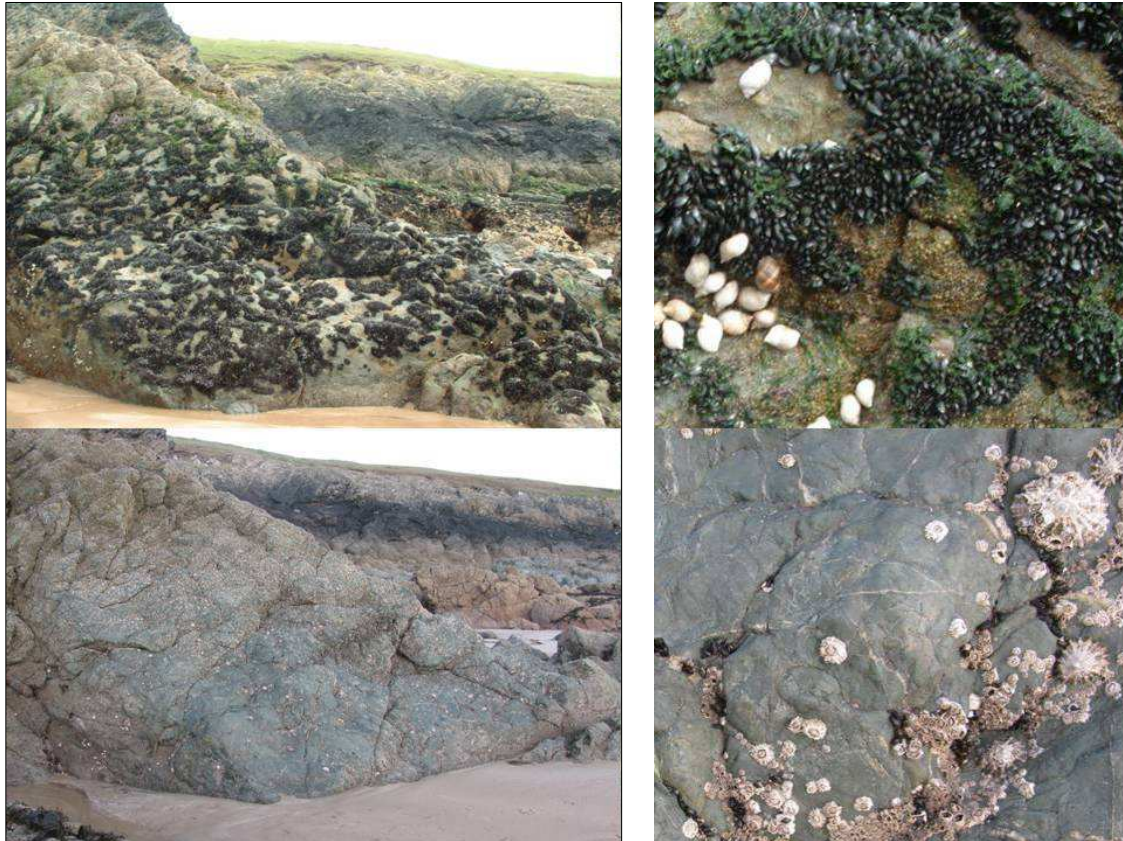
Where the extreme low shore and subtidal rock lies adjacent to sandy bays, there has been loss of algal cover and mussels *Mytilus edulis*, resulting in areas of bare rock - an unusual sight in the marine environment. The succession of fast-growing opportunist algae through to the development of a more stable community of algae, grazers and other primary consumers and predators will be evident over the coming months and years.

Figure 13. Loss of intertidal rock fauna on scoured bedrock at Aberffraw (Ivor Rees, 2<sup>nd</sup> April 2014).

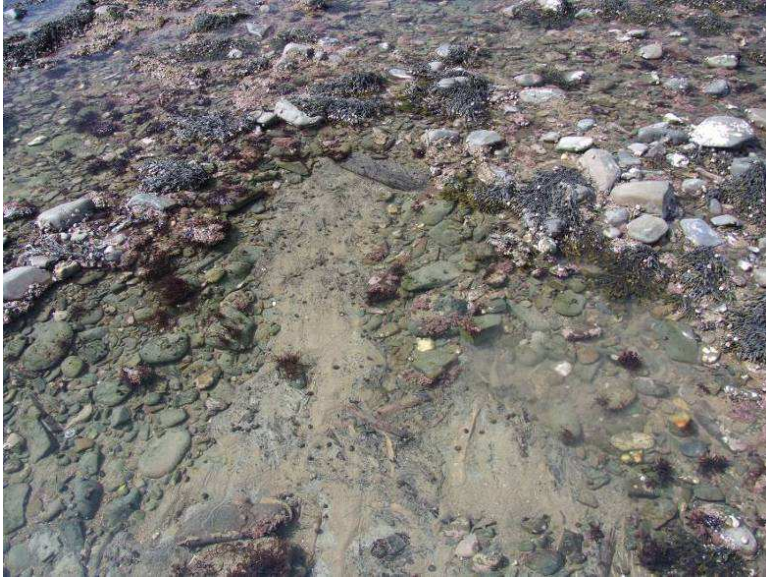
Repeat monitoring of 'Reef' features in Cardigan Bay SAC identified a number of effects from the storms. The Honeycomb reef was clearly broken up in places, revealing ancient peat and boulder clay under the surface of the boulders and cobbles that are normally bound together by the *Sabellaria alveolata* sand tubes along this stretch of coast. Typically, hollows were formed along the periphery of the reef, where loose cobbles act as grind stones, eroding away at the edges, during periods of wave action (Figure 14).

Figure 14. Mid shore at Aberaeron, clay and wood remains exposed beneath the cobble layer (Paul Brazier, 28<sup>th</sup> April 2014).

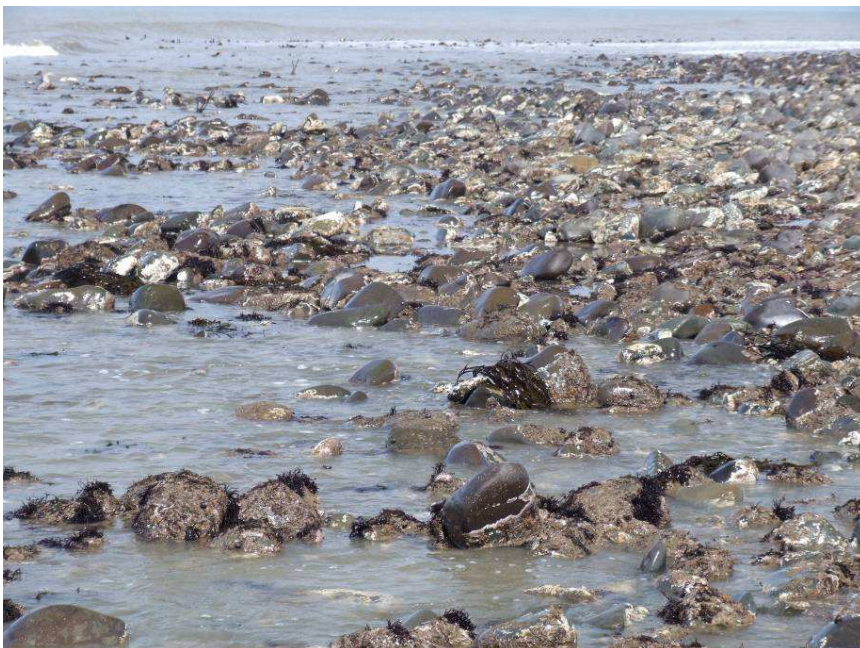
On the lower shore at Aberaeron, the wave action from the storms move a large number of boulders and cobbles from the sublittoral fringe (near subtidal) zone, higher onto the beach. The pink coralline algal crusts have subsequently bleached to show an expanse of whitened cobbles. Numerous remains of broken Kelp *Laminaria hyperborea* were also evident on the lower shore, washed up from a few metres depth (Figure 15).

Figure 15. Extreme low shore at Aberaeron, showing bleached algal crusts and stumps of kelp plant stipes (Paul Brazier, 28<sup>th</sup> April 2014).

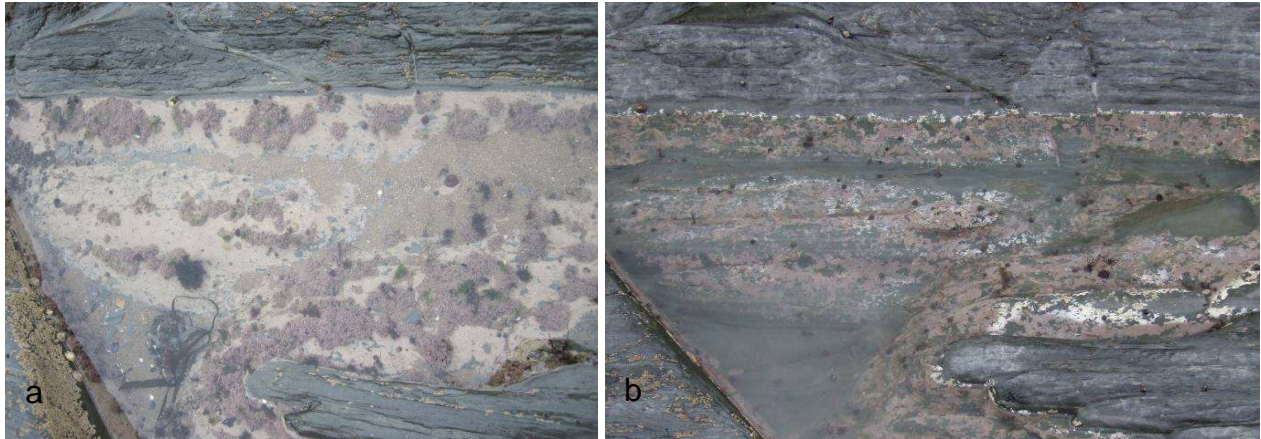
Certain of the rockpools that are part of a long term monitoring programme at Aberporth suffered severe scour and also possibly subsequent siltation. The fauna and flora were substantially impoverished where this occurred (Figure 16).

Figure 16. Upper shore pool at Aberporth, showing scoured bedrock; a) 2012, b) 2014 (Paul Brazier. 29<sup>th</sup> April 2014).

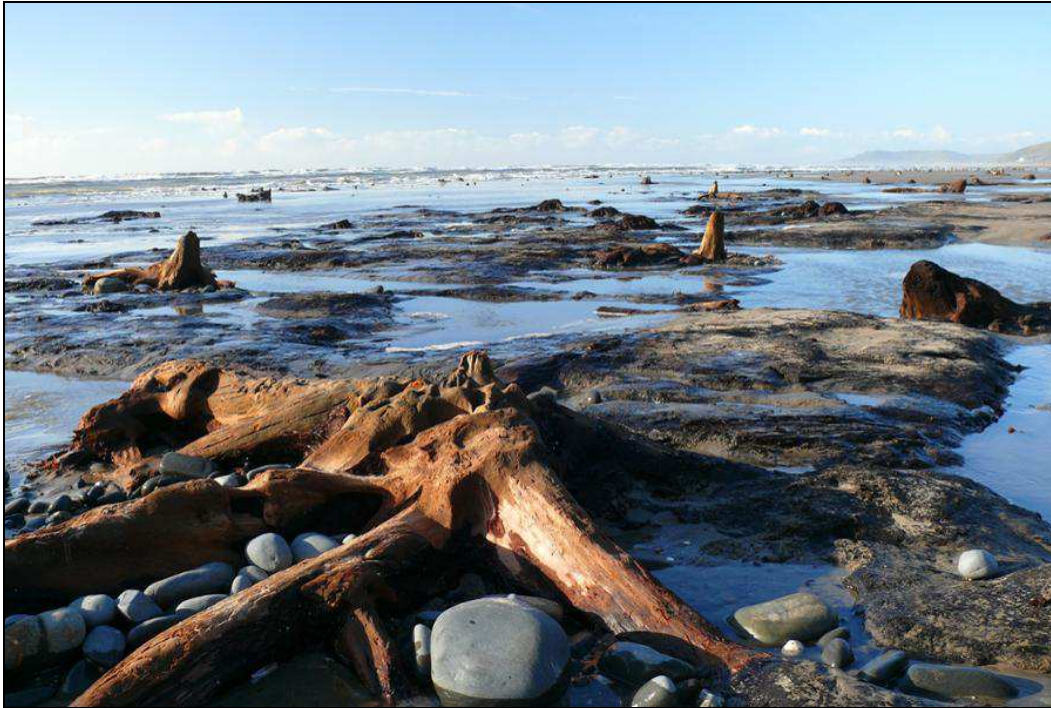
Figure 17. Exposed submerged forest at Borth (Ian Medcalf, Natural Resources Wales. 28<sup>th</sup> Feb 2014).

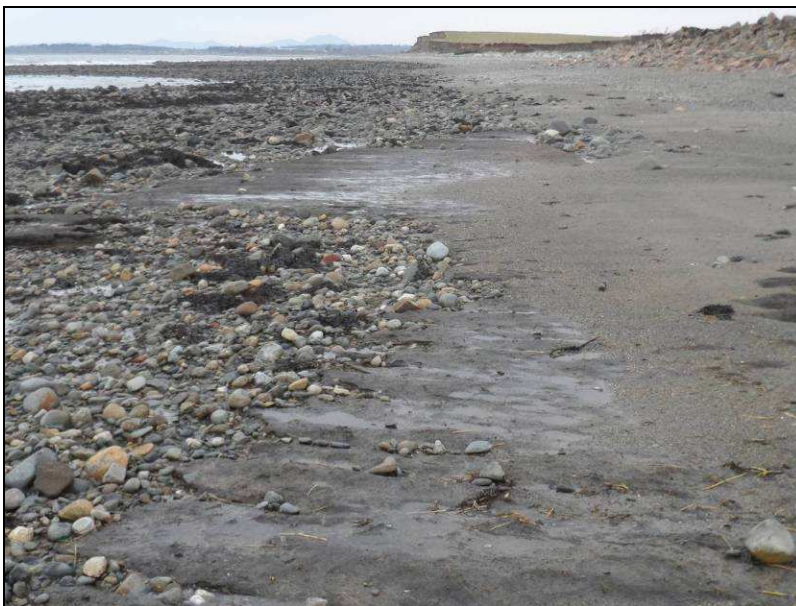
Figure 18. Exposed underlying boulder clay at Llanystumdwy (Rowland Sharp, Natural Resources Wales. 11<sup>th</sup> Jan 2014).

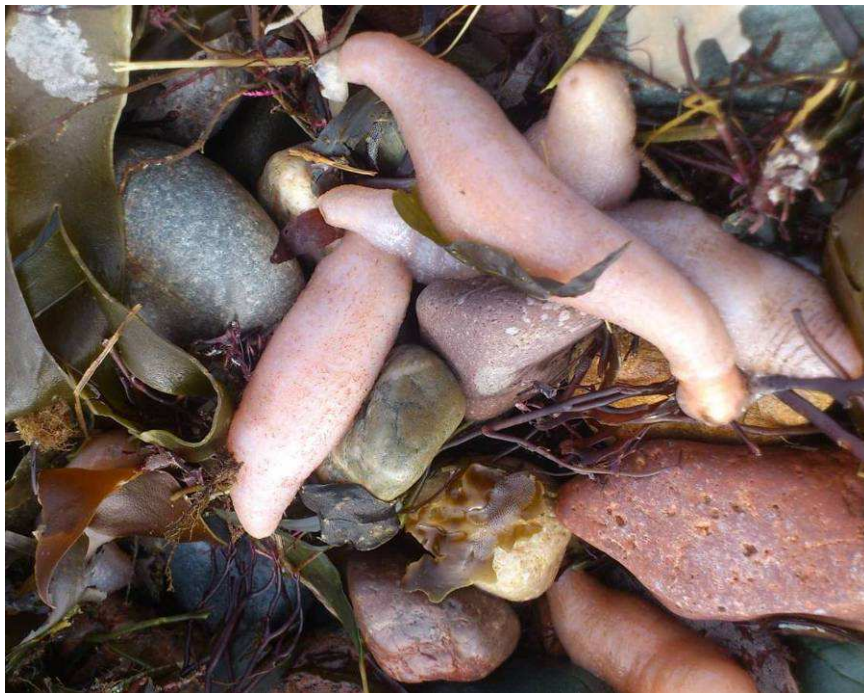
Reports on the effects of the storms on subtidal habitats are sparse, due to them being out of sight and inaccessible. There were numerous strandings of live sea cucumbers *Thyone fusus*, Otter Shells *Lutraria lutraria* and whelks *Buccinum undatus*, particularly at Morfa Dyffryn, Dinas Dinlle, Newborough Bay, Aberffraw and Gronant (Figure 19).

Figure 19. Stranded sea cucumber *Thyone fusus* at Dinas Dinlle (Bryn Jones, Natural Resources Wales. 14<sup>th</sup> Feb 2014).

A very limited view of the effects on the subtidal species is given by the various reports on the content of the strandline in days after the storm. There were numerous strandings of live sea cucumbers *Thyone fusus*, otter shells *Lutraria lutraria* and whelks *Buccinum undatus*, particularly at Morfa Dyffryn, Dinas Dinlle, Newborough Bay, Aberffraw and Gronant (Figure 19).

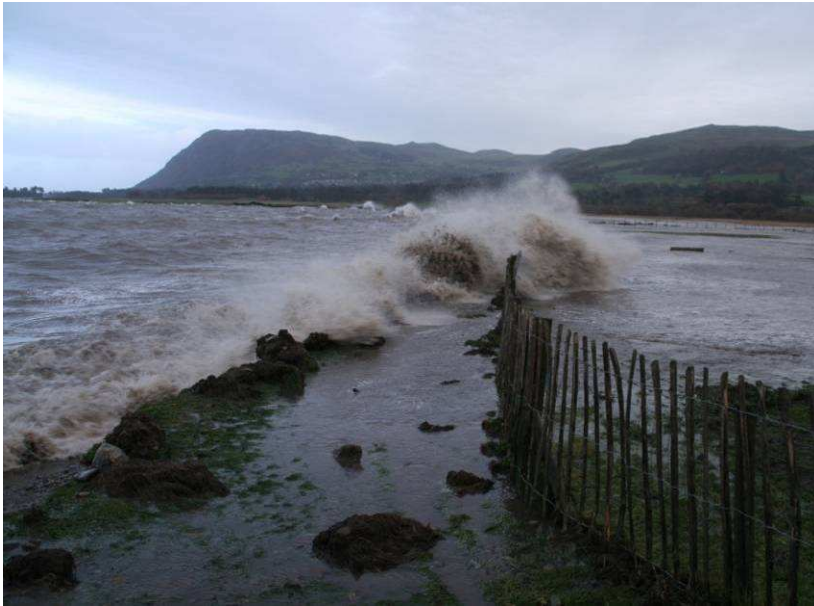
measurements have not been taken, this is likely to have partially increased the salinity of some of the pools, which will affect the feeding opportunities for certain bird species (Figure 20).

Figure 20. Overtopping of the floodbanks at Morfa Madryn, Llanfairfechan (John Ratcliffe, Natural Resources Wales. 5<sup>th</sup> Dec 2013).

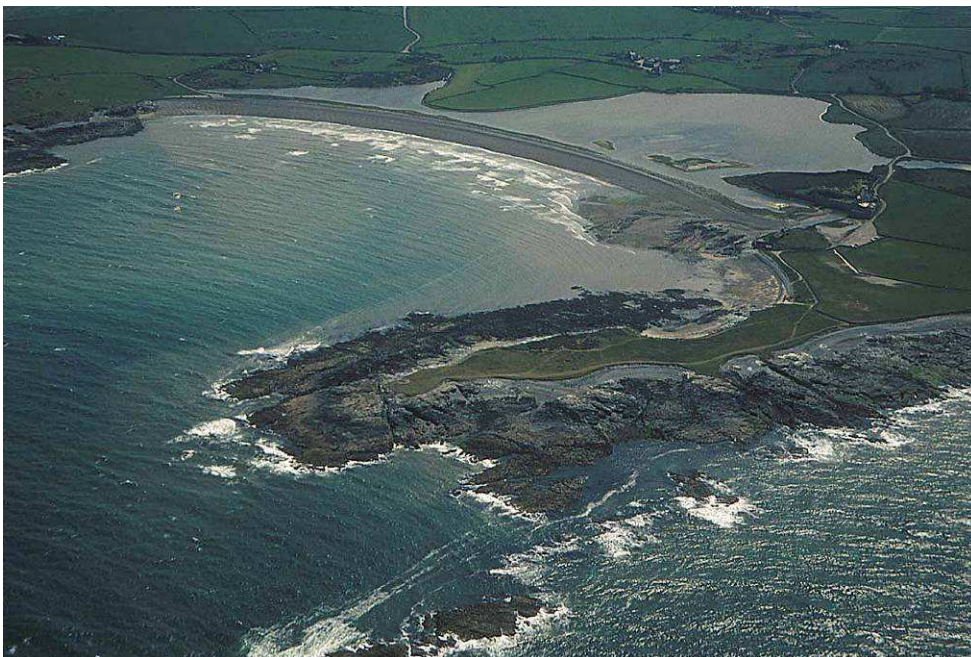
At Cemlyn Lagoon, Anglesey (Figure 21), wave action pushed shingle to the top and over the crest of the shingle ridge, resulting in the crest being lowered (by up to 50cm) and moved landward (Figure 22), and changes to water levels and salinity. Shingle also moved westwards, influencing the area of the sluice and some has been lost to the road and car park. Previous storms have had similar effects, with gradual evolution of the lagoon. Remedial work to the topography of the lagoon each time maintains the tern nesting sites.

Figure 21. Cemlyn Lagoon aerial image (Rohan Holt, Joint Nature Conservation Committee. circa 1996).

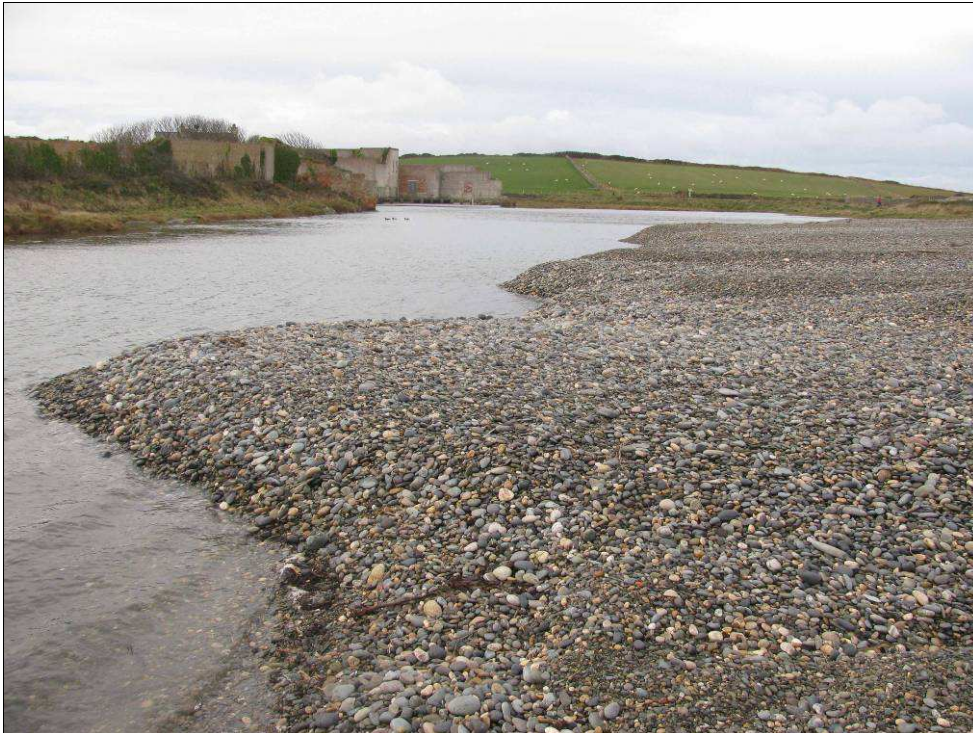
Figure 22. Cemlyn Lagoon shingle accumulating in the lagoon (Ivor Rees, 7<sup>th</sup> Dec 2013).

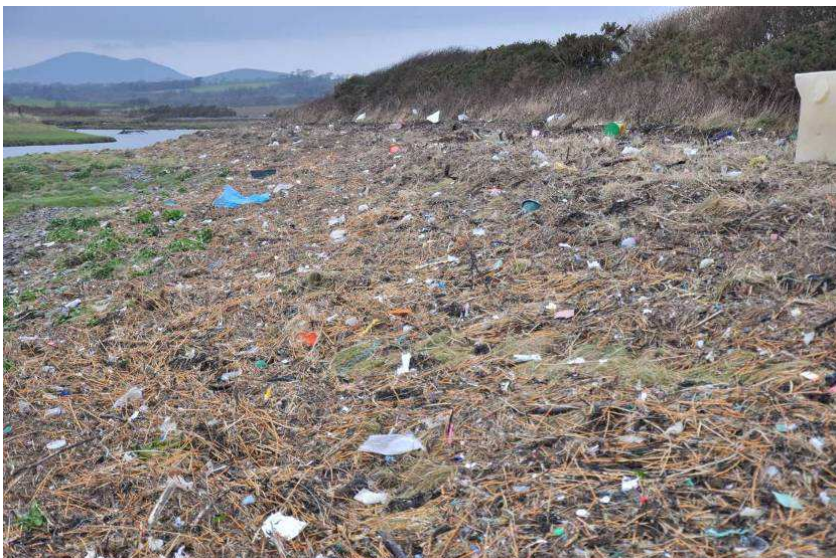
The high spring tides and storm surges have resulted in flooding of estuary saltmarsh, leading to large strandings of organic material mixed in with litter and some incidences of damage to sluices (Figure 23). Where tides and waves have overtopped the floodbanks, flooding has accessed low-lying grazing fields, causing welfare issues for farm animals and damaged swards. In the Dee estuary, overtopping of the southern, mid-estuary shoreline may have caused minor erosion of the saltmarsh edge. The presence of organic debris on the upper saltmarsh is considered to be a naturally occurring event and part of the cycle of nutrients in a saltmarsh system.

Figure 23. Litter debris at Afon Dwyfor (Paul Brazier, 12<sup>th</sup> Jan 2014).

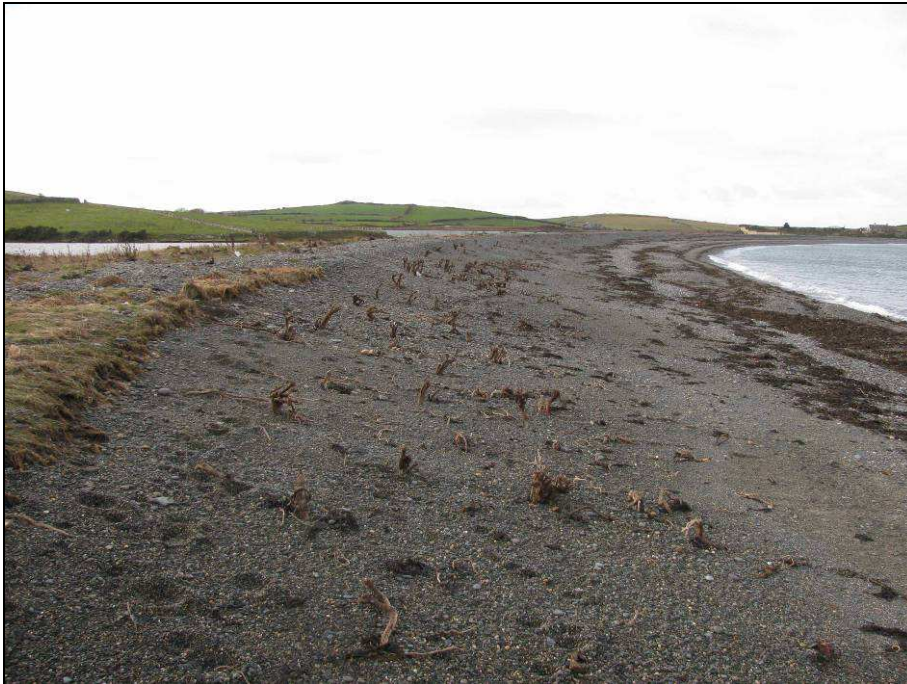
At Cemlyn Bay, the shingle ridge was lowered and the crest moved inland as a result of wave action. Parts of the ridge appear to be up to 50cm lower than sections either side, whilst the roots of Sea-kale *Crambe maritima*, some up to 20cm long, have been left exposed on the crest of the ridge, indicating a local reduction in the crest height (Figure 24). At the west end of the ridge, more stable cobbles have been undercut and material lost from the area (Figure 25).

Figure 24. Vegetated shingle ridge at Cemlyn showing eroded sea kale on the ridge front (Ivor Rees, 7<sup>th</sup> Dec 2013).

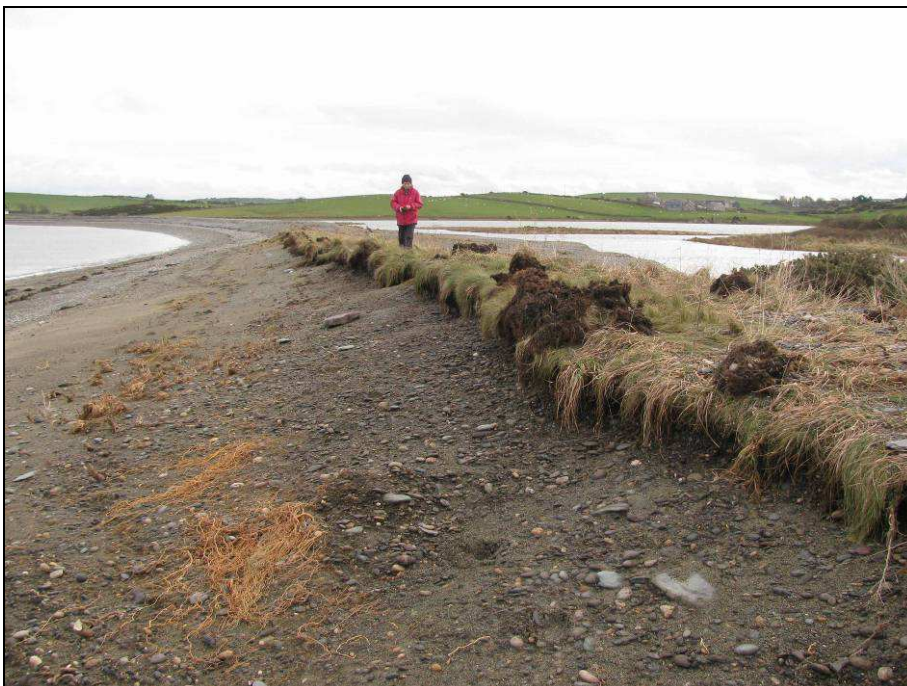
Figure 25. Vegetated shingle ridge at Cemlyn showing erosion at the west end (Ivor Rees, 7<sup>th</sup> Dec 2013).

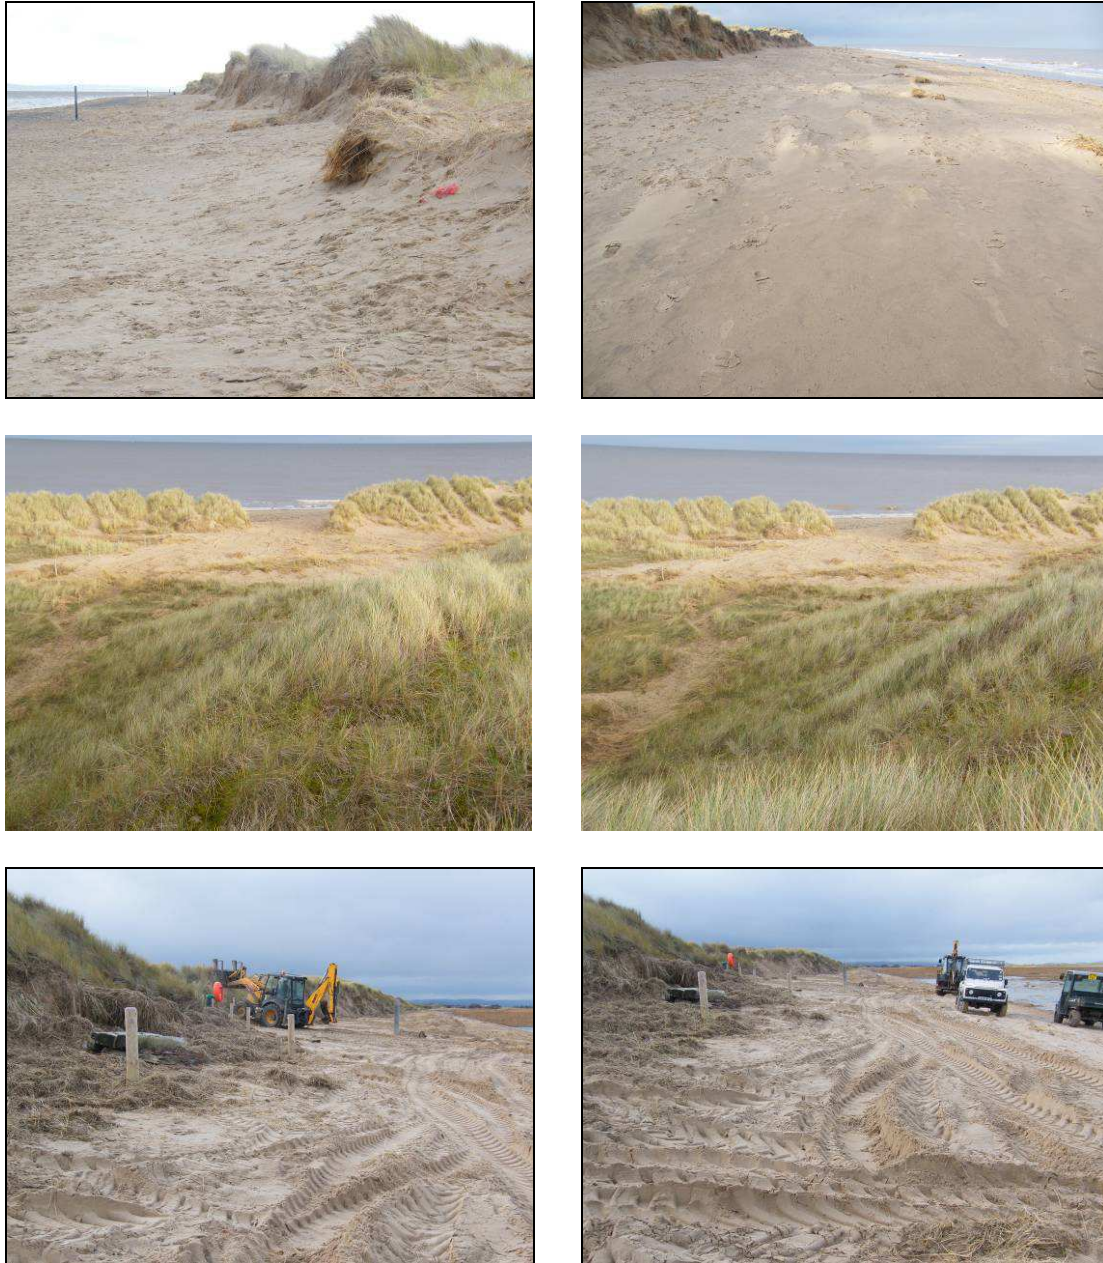
Loss of frontal dune habitat varies from 1m at western end to more than 10m at Point of Ayr as a consequence of storm surges in early December 2013. Frontal dunes at Point of Ayr were breached in about four locations, allowing saline intrusion into an area between two ridges. Whilst water could access this area through an existing route, recent changes will increase the risk of more frequent flooding. The breaches were repaired for coastal defence purposes, and areas of truncated fore dunes in front of Presthaven Sands Holiday Park were bulldozed to provide a higher barrier to further erosion. The erosion of frontal dunes has exposed old fencing posts and wiring, creating a health and safety hazard.

Figure 26. The impact of December storms on Talacre Warren (Mike Howe, December 2013).

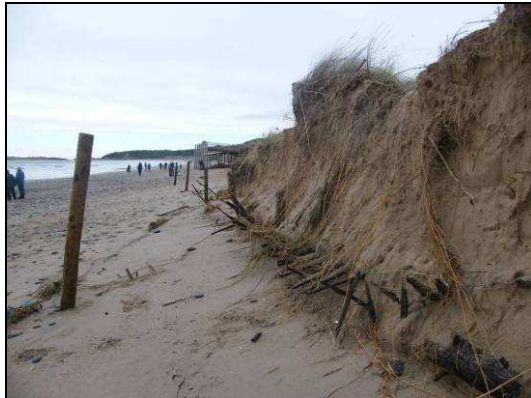
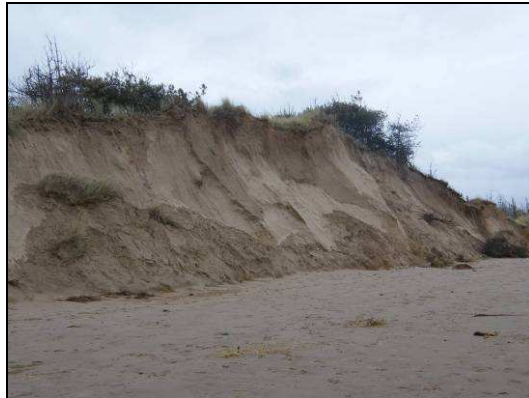
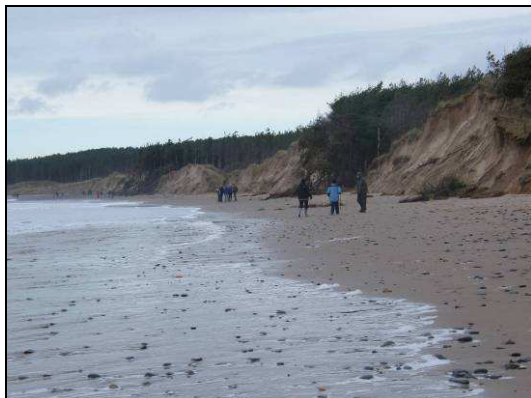
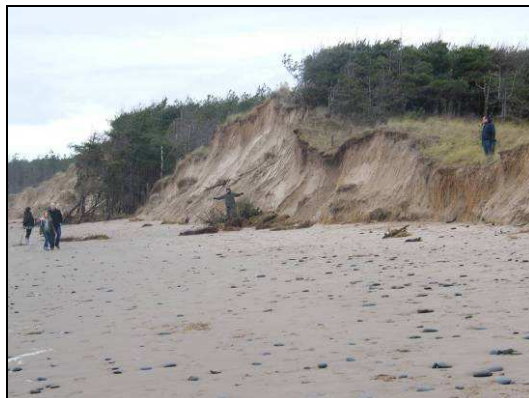
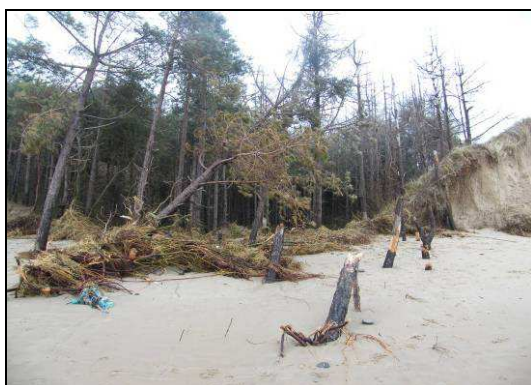
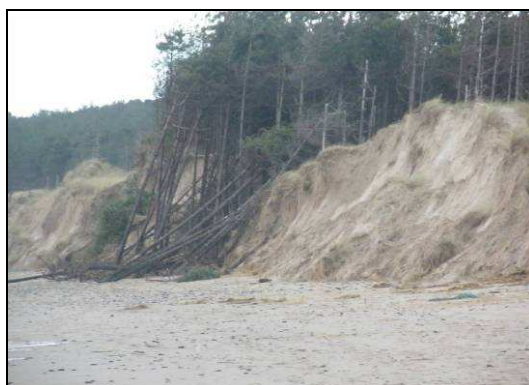
Storm surges from late December 2013 to February 2014 resulted in lowering of the beach and the loss of 10m of frontal dune along much of the shoreline, with a maximum retreat of 15 to 20m. Losses of frontal dune are estimated at 3.5ha, with loss of approximately 85,000 m<sup>3</sup> of sand. The viewing platform constructed in March 2013 was undermined in December 2013 and collapsed in early January 2014 and there were significant losses of conifers onto the beach as the sea undermined the plantation. Dune frontage retreat is in line with that forecast by Pye & Saye (2005). Extensive salt-burn of the conifer plantation is becoming apparent.

Figure 27. Impact of winter storms at Newborough Warren (Mike Howe & John Ratcliffe, Jan 2014).

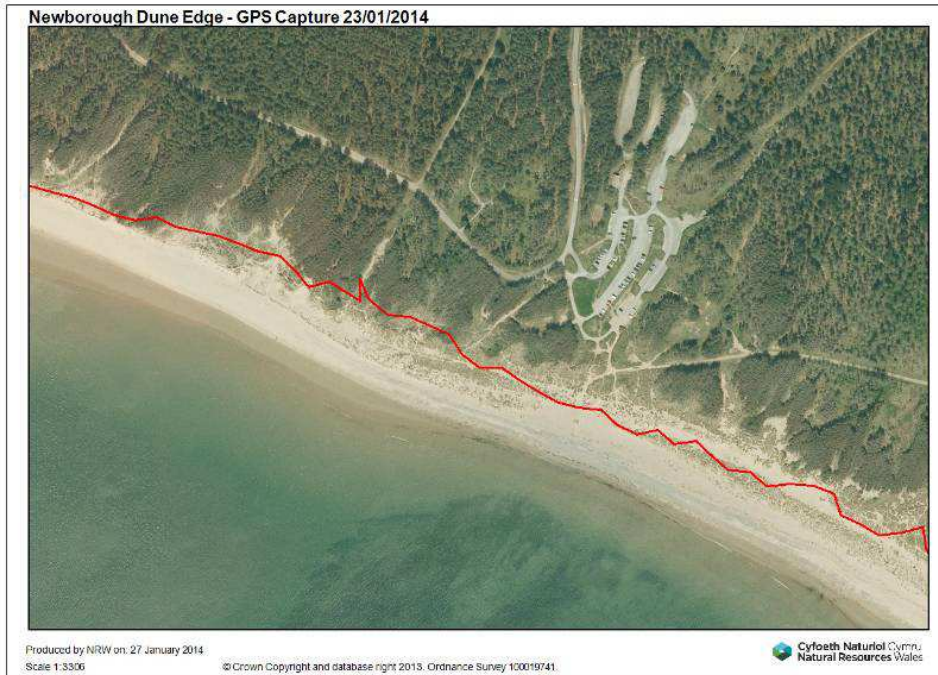
Figure 28. Retreat of frontal dunes at Newborough Warren after the winter storms. Red line indicates current line of frontal dunes compared to the situation in 2009.
