# Welsh Coastal Storms, December 2013 & January 2014 – an assessment of environmental change

Natural Resources Wales Evidence Report No. 33  
July 2014

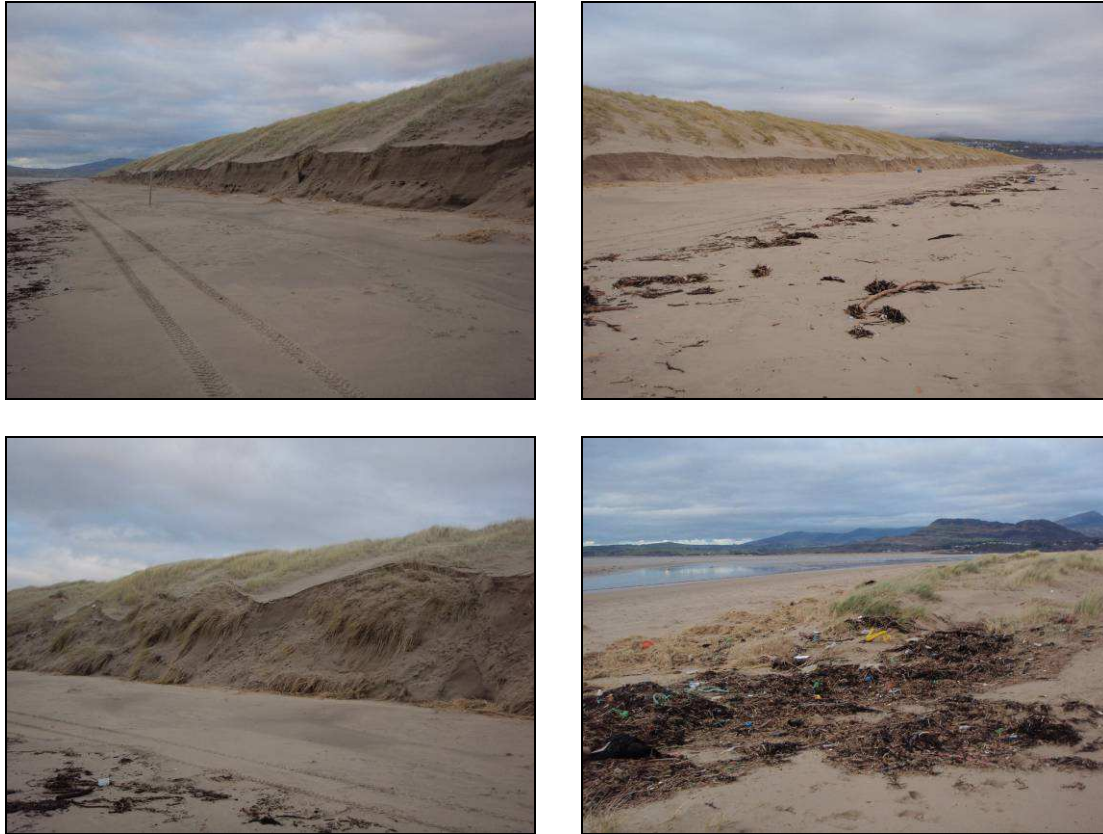
Figure 29. Impact of winter storms on frontal dunes at Morfa Harlech (Rhodri Dafydd, Jan 2014).

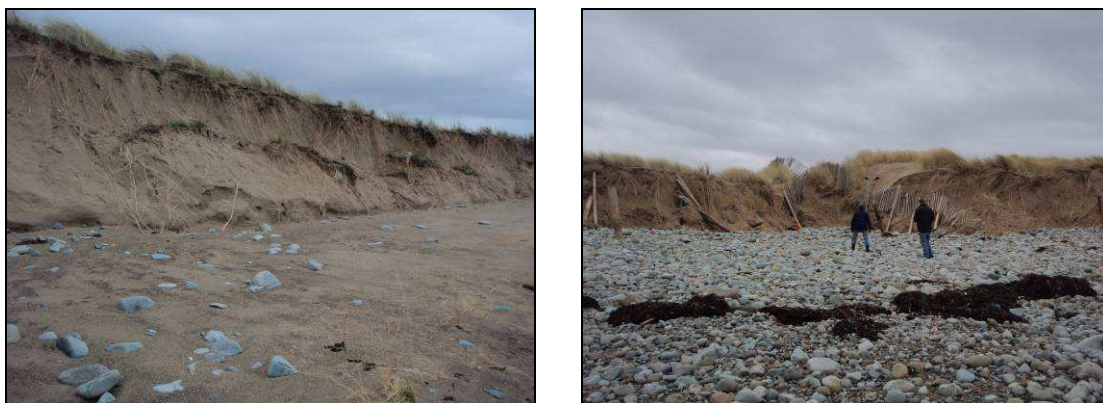
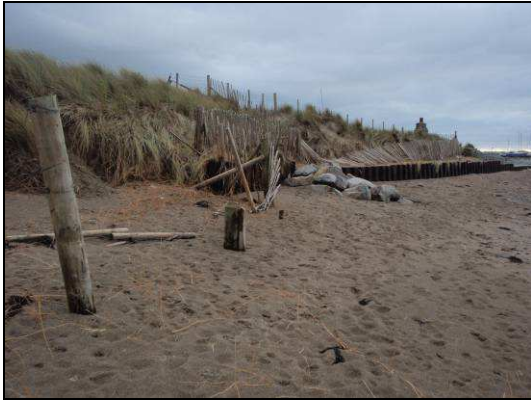
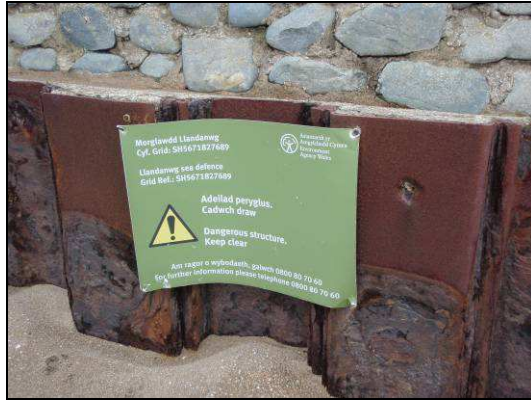
There has been severe erosion of this small dune system which is part of Natural Resources Wales' coastal defences. A key issue is nature of any future works in this area in line with the Shoreline Management Plan 2 (SMP2) draft policies. There is local interest in retaining the dunes, but this is unsustainable in the longer term and the SMP2 report advocates an integrated Arthro estuary-wide project to look at this whole section of coast in terms of its future management and implementing options that are more self-sustaining in the future.

Figure 30. Frontal dunes at Morfa Llandanwg (Rhodri Dafydd, Jan 2014).

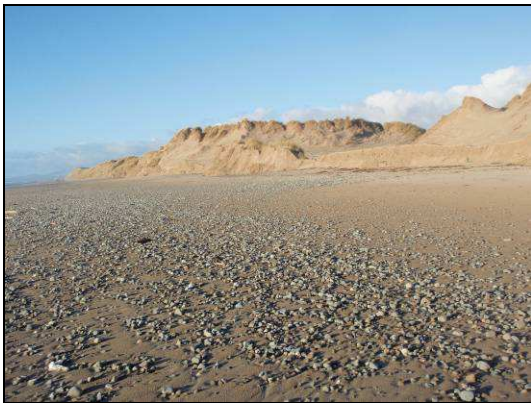
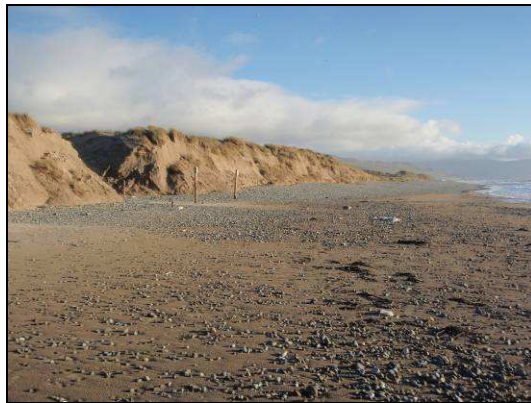
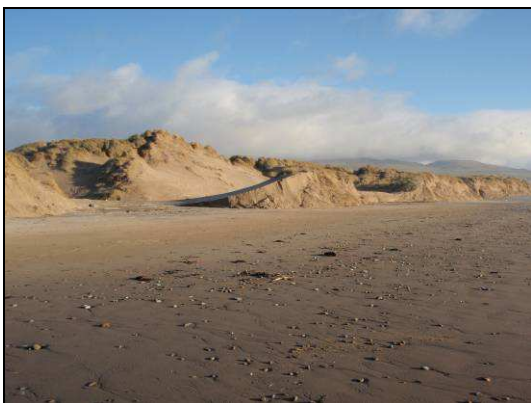
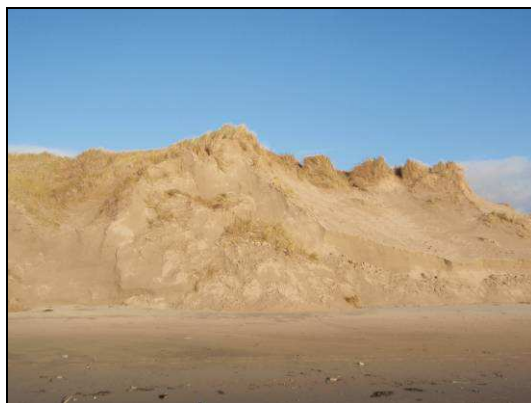
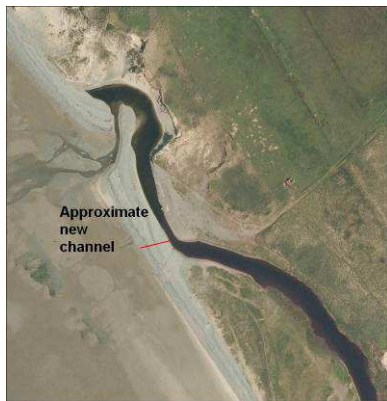
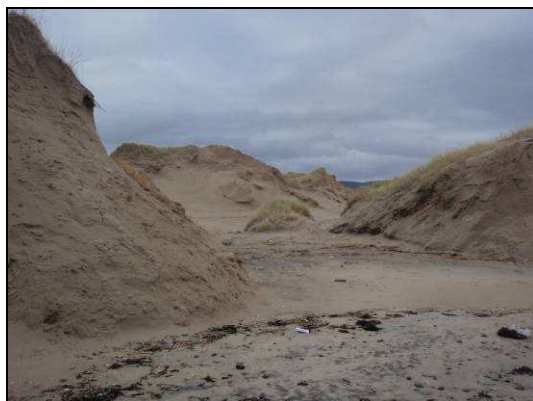
Storm surges have resulted in a northward migration of shingle along beach, the movement of shingle ridge inland and breached at some locations into dune blowouts. Movement of shingle has closed off the lagoon at the mouth of the Afon Ysgethin which has cut a new course through the beach. Frontal dunes have eroded and become truncated along their entire length (c.3.5km). None of the dunes have been breached to such an extent to cause inundation of low-lying land.

Figure 31. Changes to the frontal dunes at Morfa Dyffryn following winter storms (Rhodri Dafydd, Jan 2014).

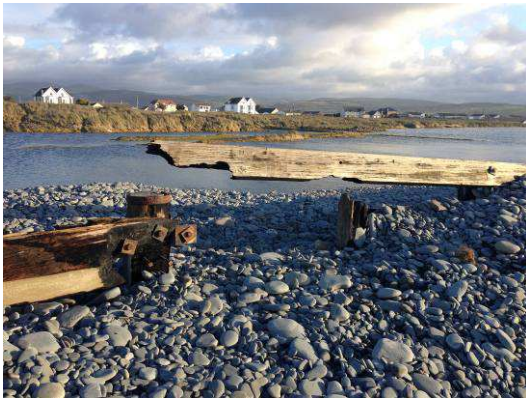
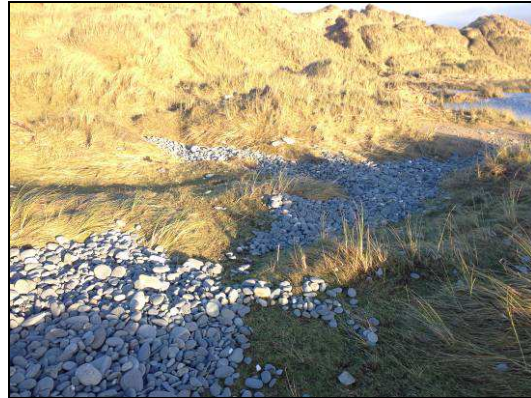
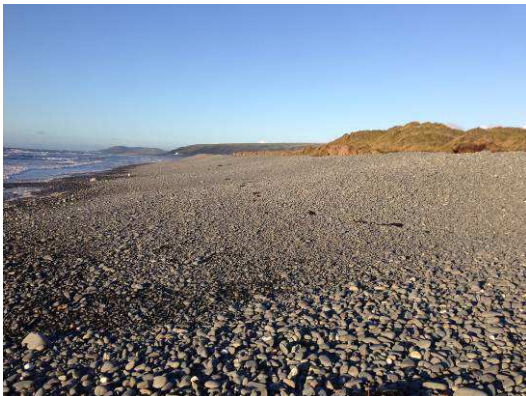
Figure 32. Changes to the dune frontage at Ynyslâs Dunes (Mike Bailey & Jill Bullen, Jan 2014).

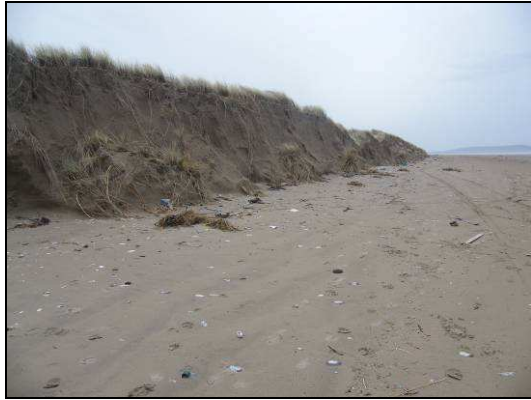
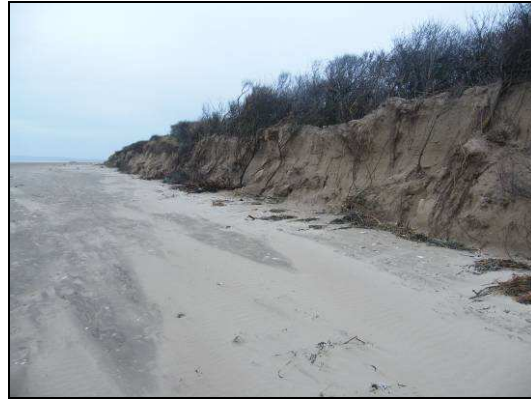
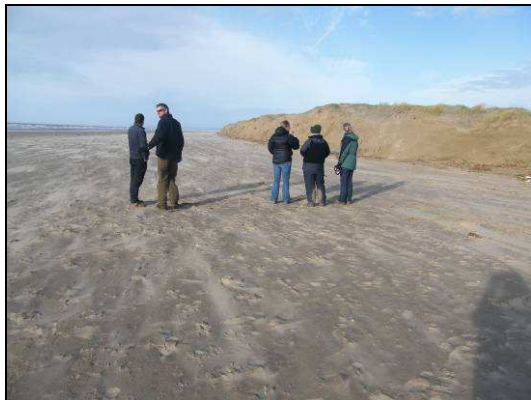
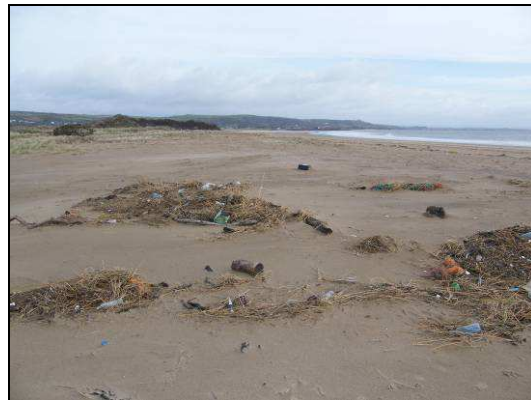
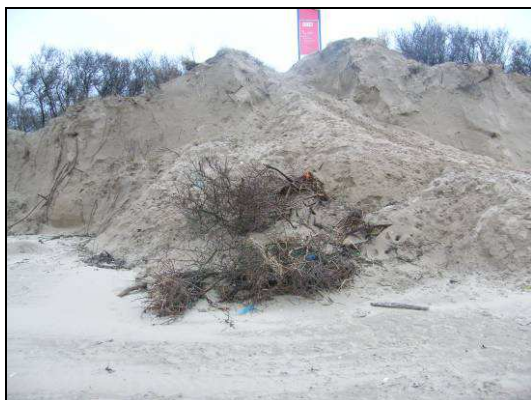
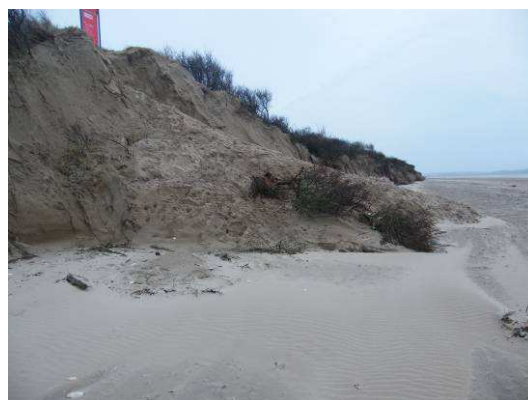
Tall sand cliffs are in a dangerous condition and may need bull-dozing to make safe for the public.

Figure 33. Frontal dunes at Pembrey Burrows (Mike Howe, Jan 2014).

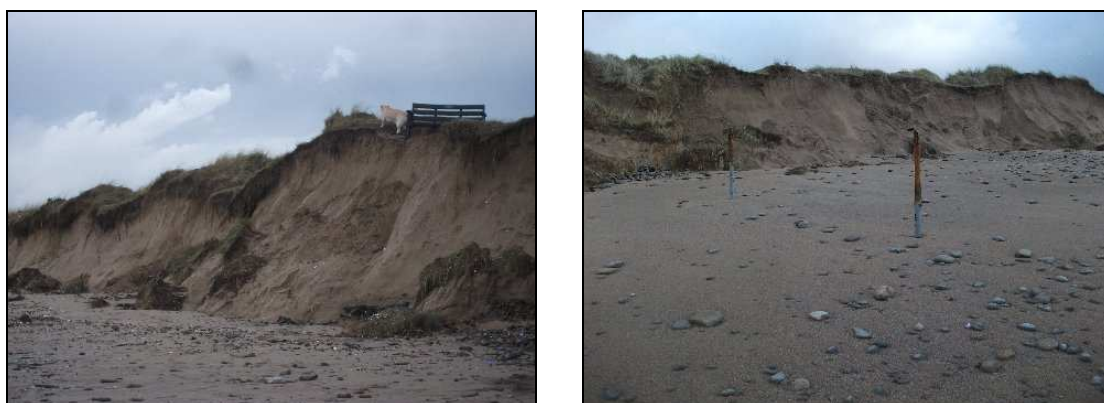
Figure 35. Frontal dunes at Kenfig (David Carrington & Scott Hand, Jan 2014).

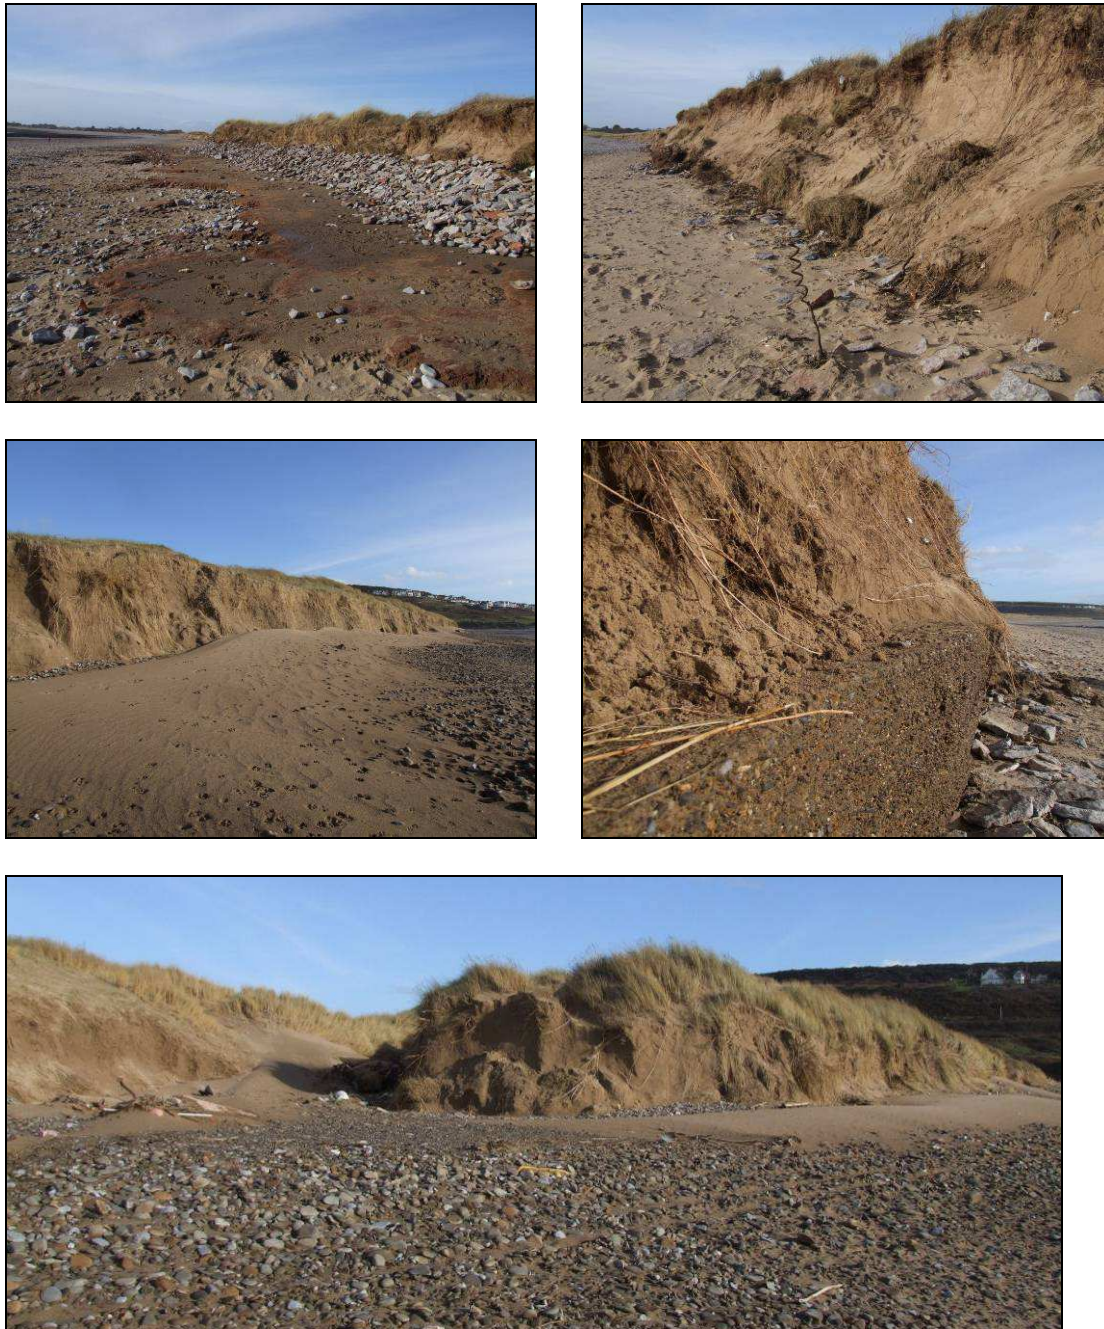
Figure 36. Frontal dunes at Merthyr Mawr following the winter storms (Duncan Ludlow, Jan 2014).

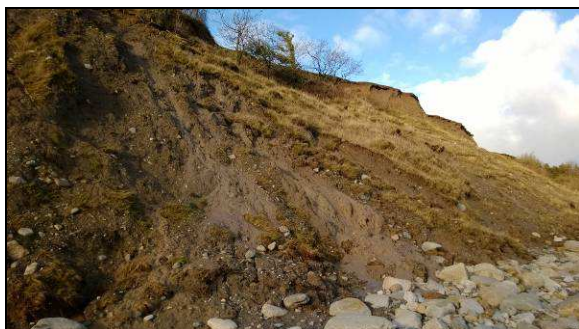
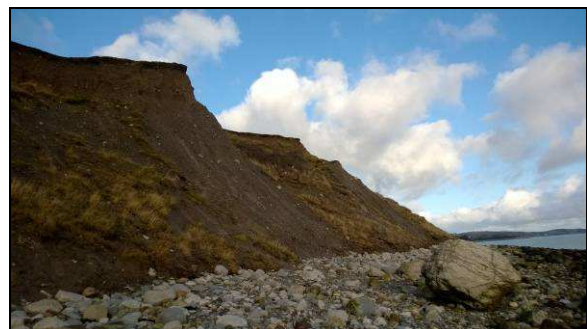
Some erosion of the cliff face.

Figure 37. Soft cliffs at Beaumaris (Jean Matthews, Jan 2014).

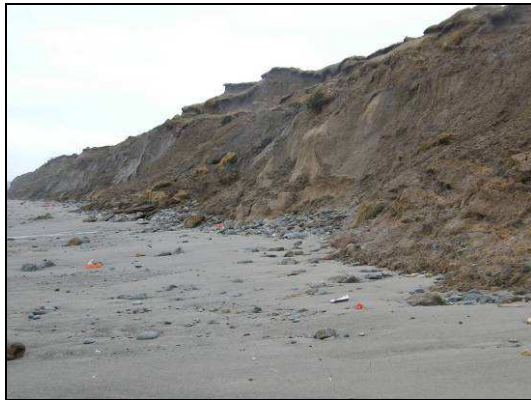
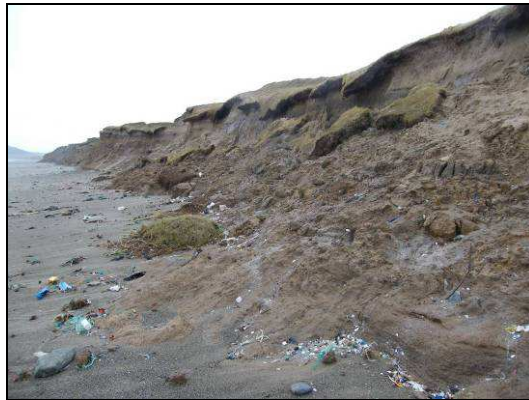
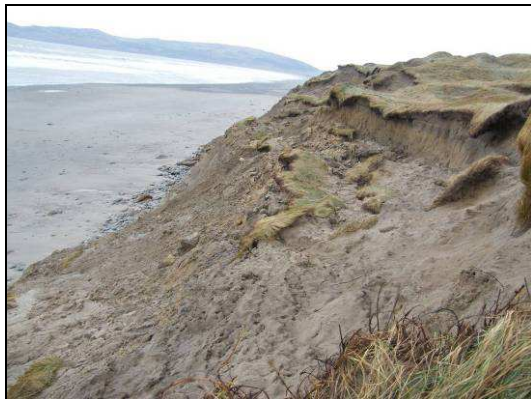
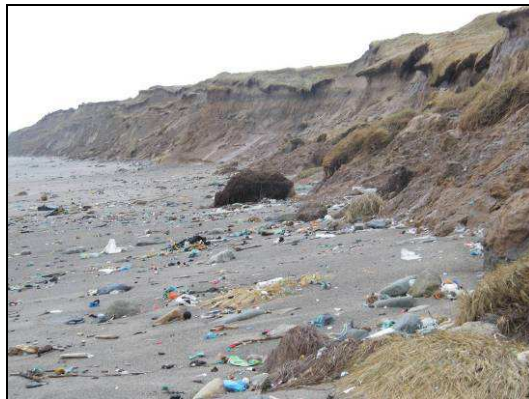
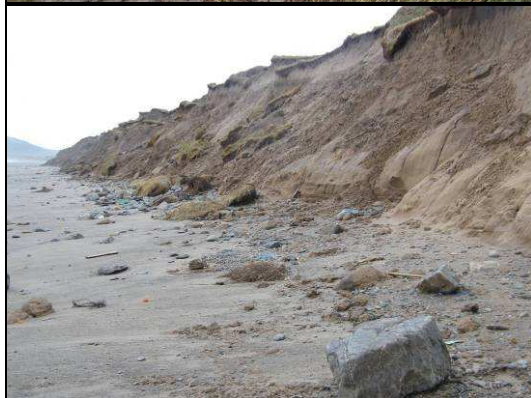
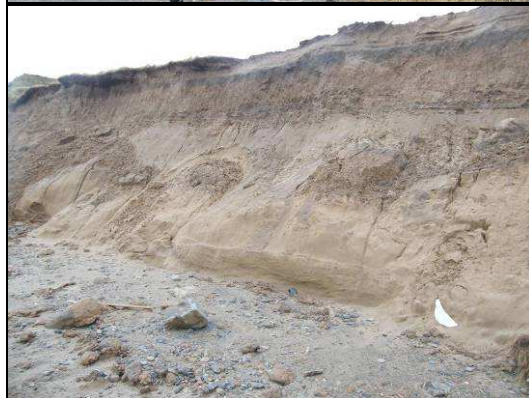
Retreating at an annual rate of 0.5m (Harrop 1994), the soft cliffs at Porth Neigwl have eroded back significantly this winter. At the eastern end of the bay, much of the vegetation has been stripped off the cliff slopes leaving bare glacial till and sand, and seepages on the slopes have been temporarily effaced. Sandy faces are likely to be further eroded by high winds and tides during the remaining winter period. This will have had an impact upon key invertebrates associated with soft cliff habitats (see Annex 1, 8.1.3).

Figure 38. Erosion of the cliff faces at Porth Neigwl (Mike Howe, Feb 2014).

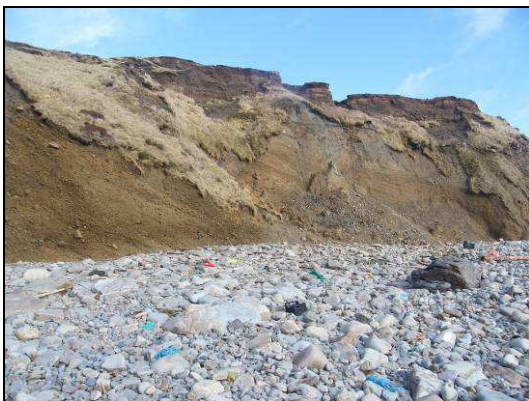
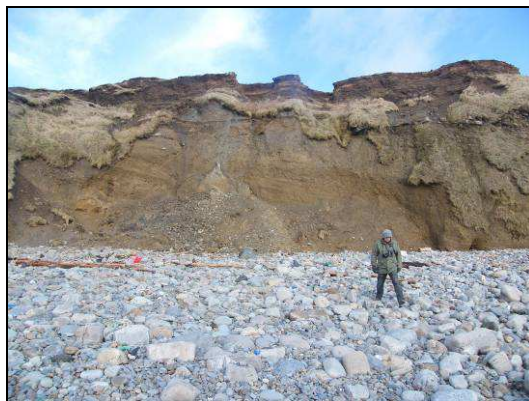
Porth Ceiriad has experienced major slippages along its entire length, these being particularly pronounced at the western end. Sand lenses have been lost from the cliff slope and seepages have been temporarily effaced. This will have had an impact upon key invertebrates associated with soft cliff habitats (see Annex 1, 8.1.3).

Figure 39. Erosion of soft cliffs at Porth Ceiriad (Mike Howe, Feb 2014).

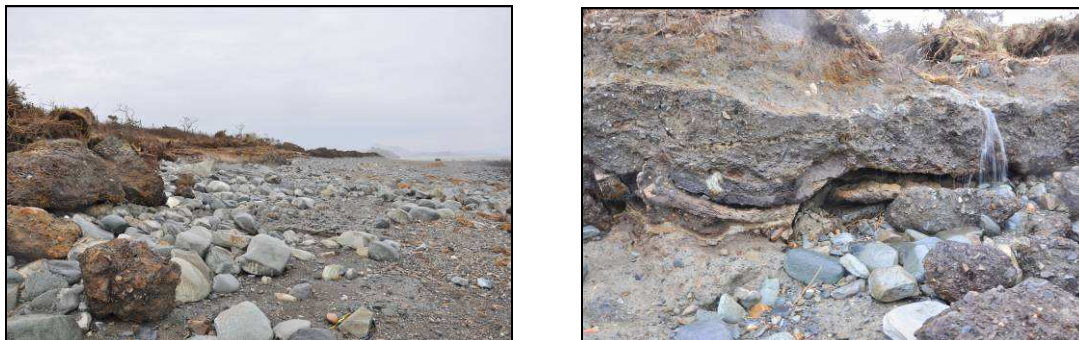
Soft boulder clay cliffs have eroded and slumped in a number of places. Upper-shore shingle (cobbles) and mid- and upper-shore sand have been removed from the site. The material has gradually washed down shore, seriously affecting the turbidity of the seawater along adjacent stretches of the coast.

Figure 40. Changes at Afon Dwyfor & Afon Wen (Paul Brazier & Rowland Sharp, Jan 2014).

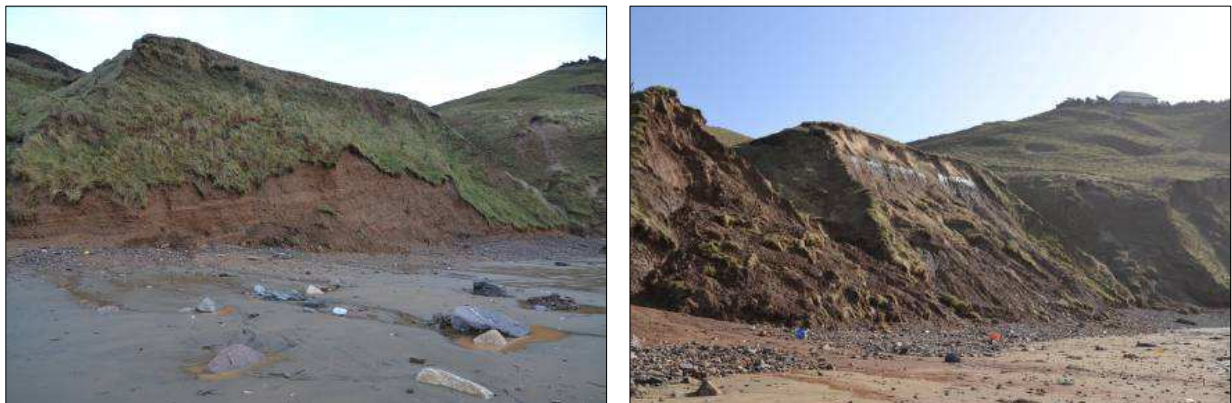
Figure 41. Changes at Rhossili Bay. 13<sup>th</sup> January 2014 & 26<sup>th</sup> February 2014 (Alan Kearsley-Evans).

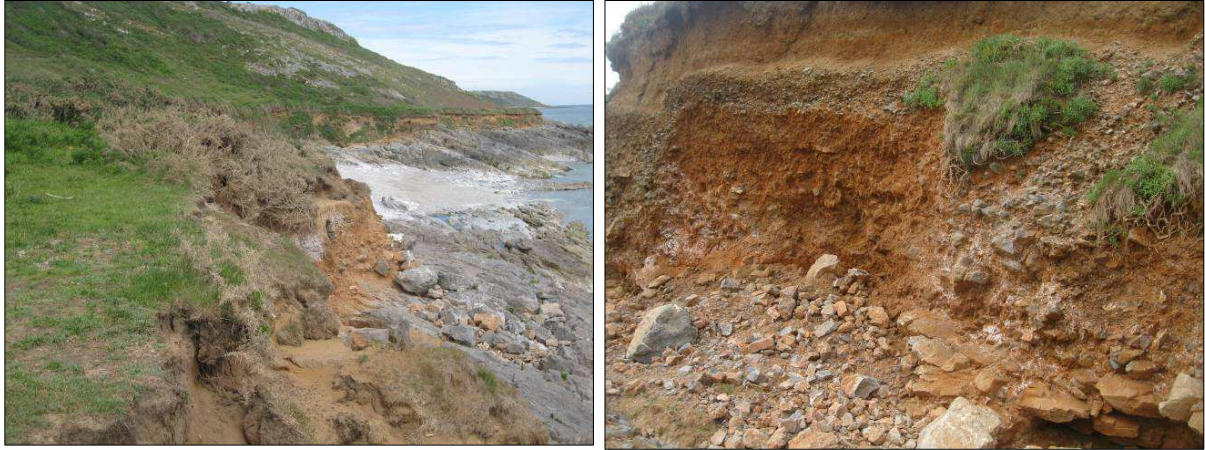
Figure 42. Small-scale erosion at Horton Cliff (Mike Howe, June 2014).

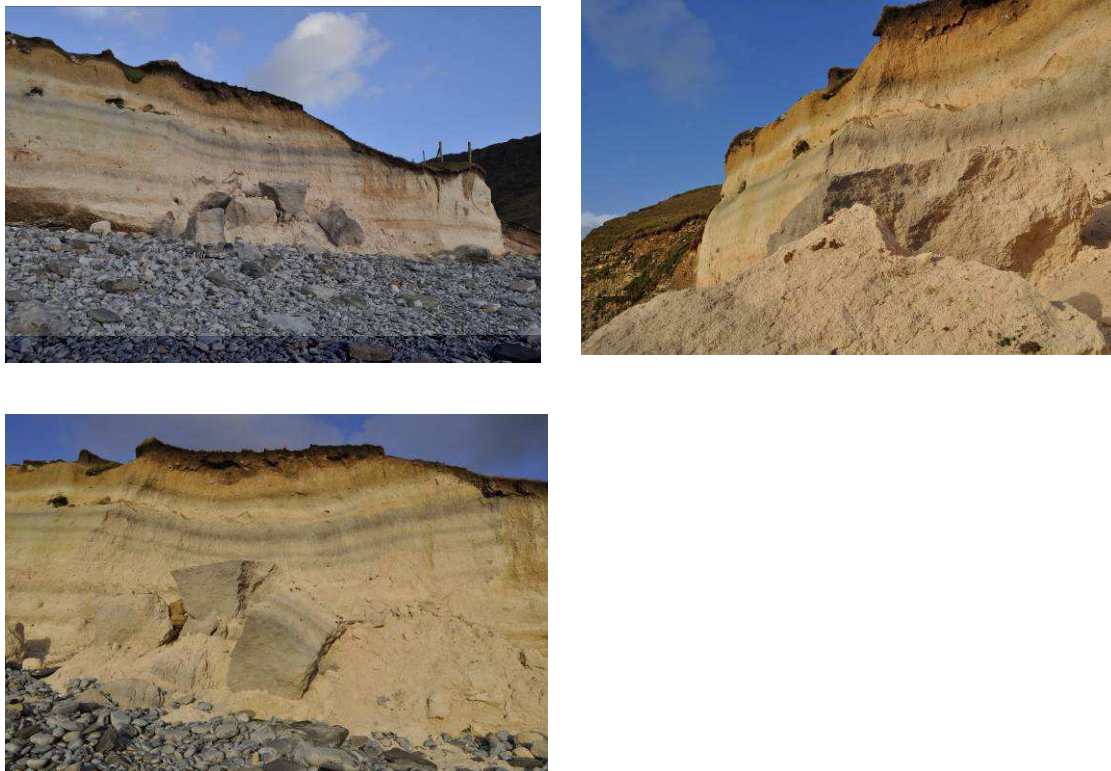
Figure 43. Tufa cliff collapse, 7th - 9th January 2014 (Chris Byrne).

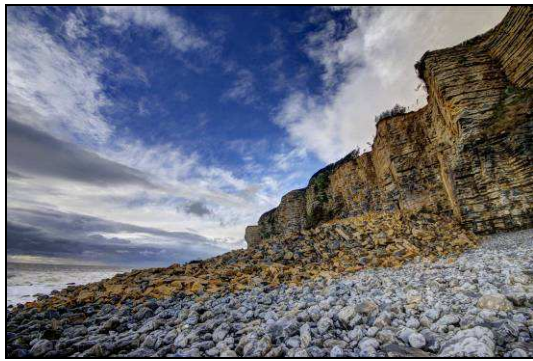
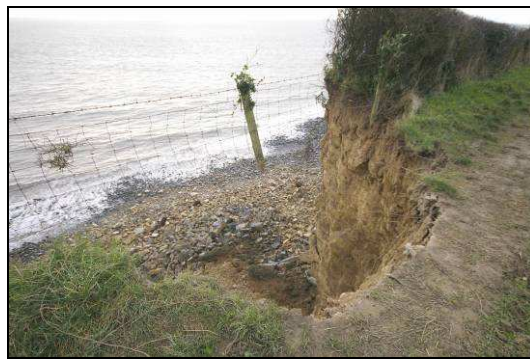
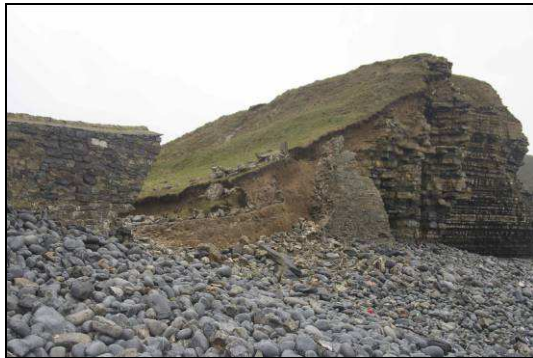
On the Glamorgan Heritage Coast, the limestone cliffs can erode at similar rates to soft deposits. Slippages of these limestone cliffs at Dunraven Bay have occurred as a consequence of wave action and rainfall, and may have impacted upon the population of Shore Dock *Rumex rupestris*, a Habitats Directive Annex II species and a Qualifying feature of the SSSI.

Figure 44. Three views of Dunraven Bay (Paul Dunn, Jan 2014).

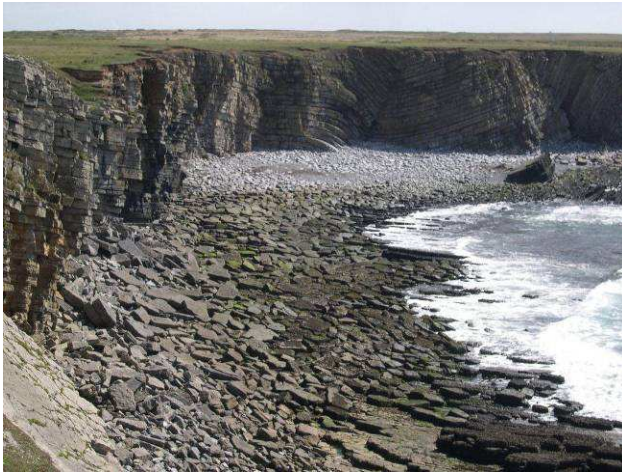
Calcareous grasslands are disproportionately well represented close to the coast, due largely to the fact that much of the Carboniferous and other hard limestone bedrock in Wales is coastal. At most sites, the calcareous grassland habitat closest to the sea is situated on high cliff tops or slopes, as for example is largely the case at Great Orme's Head (Pen y Gogarth/Great Ormes Head SSSI) in Conwy. In some cases, however, stands of the habitat are distributed right up to the cliff edge and are therefore vulnerable to loss through cliff erosion e.g. at Castlemartin Range SSSI in Pembrokeshire (Figure 46). There have been no reports of this having occurred so far however.

Figure 46. Lowland grassland reaching cliff edge, Castlemartin Range SSSI, Pembrokeshire (Stuart Smith).

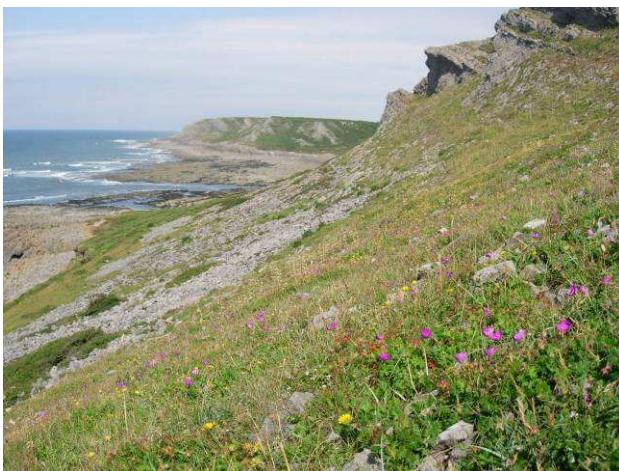
Transitions from maritime grassland to terrestrial lowland grassland are particularly well-established on some of the Gower coast SSSI (Figure 47). There is a long-term risk here of expansion of the maritime grassland at the expense of highly valued terrestrial grassland should violent storm events become more frequent in the future (compounded by any rise in sea level). This could potentially be assessed during

Figure 47. Terrestrial to maritime grassland transitions, Gower coast, West Glamorgan (Stuart Smith).

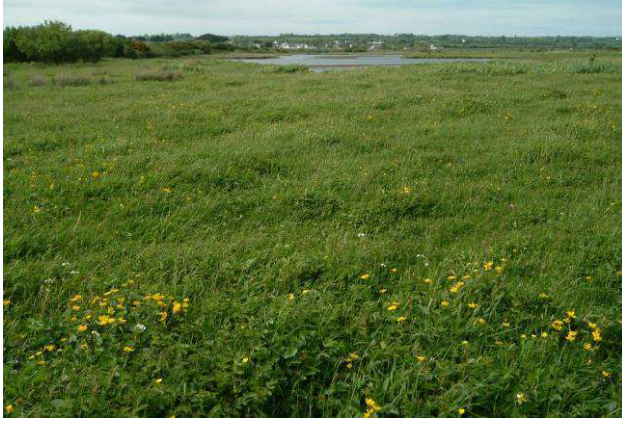
Only a very small proportion of unimproved neutral grasslands in Wales are located close to the coast, although some particularly uncommon forms of the habitat are at risk. For example, the largest known area (in Wales) of the National Vegetation Classification (NVC) community *Cynosurus cristatus* – *Caltha palustris* grassland (MG8) occurs just beyond the sea wall at Malltraeth Cob on Anglesey (Newborough Warren – Ynys Llanddwyn SSSI) (Figure 48) and would be vulnerable to any breach.

Figure 48. MG8 grassland behind sea wall at Malltraeth, Anglesey (Stuart Smith).

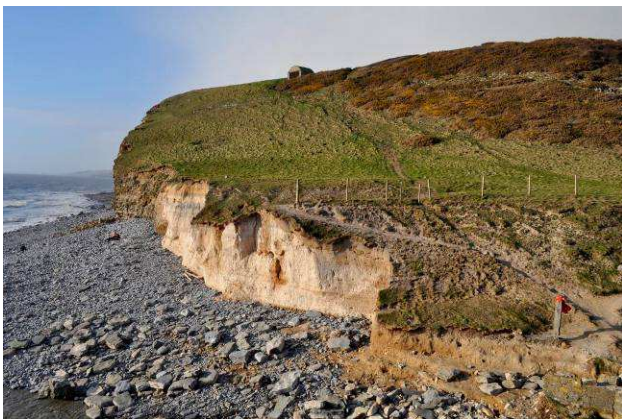
Some examples of the scarce MG5b sub-community (*Cynosurus cristatus* – *Centaurea nigra palustris* grassland, *Galium verum* sub-community) are located on cliff tops at Castlemartin Range SSSI (Figure 46) and on coastal slopes on a few SSSIs in South Glamorgan, among them Monkash Coast SSSI. With an estimated loss of between 1 and 2m of tufa and limestone cliff at Cwm Nash (part of Monkash Coast SSSI; Figure 49), there has been a loss of maritime grassland here, but it is yet unclear whether adjacent stands of MG5b have been affected.

Figure 49. Cliff erosion in winter 2013/14 threatening MG5b sub-community of vegetation at Cwm Nash, South Glamorgan (Christina Byrne, Natural Resources Wales)

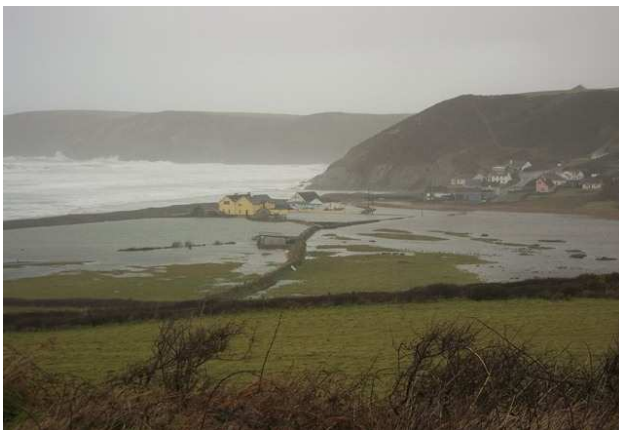
The sea protection at Newgale in Pembrokeshire was breached by sea water on at least three occasions in winter 2013/14 (Figure 51), notably in early February when the stranding of a bus hit the national news. Although not notified as a SSSI, the hinterland marshland is of high conservation value and is clearly very likely to have been adversely affected by the inundation.

Figure 51. Inundation of terrestrial grassland habitat at Newgale, Pembrokeshire (Jon Hudson, Natural Resources Wales).

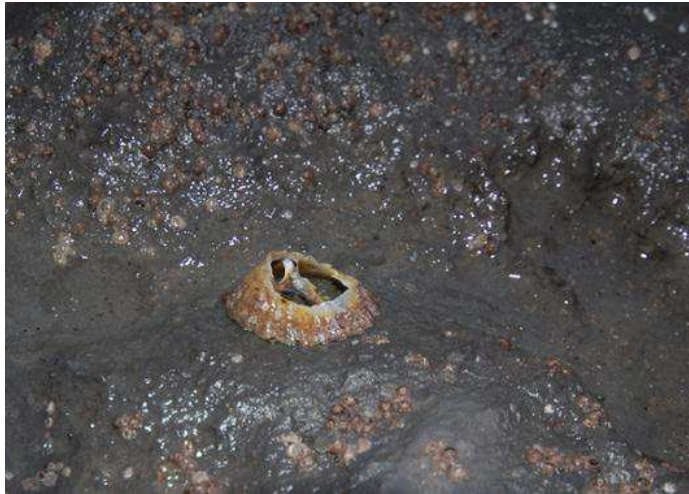
Figure 52. Damaged limpet *Patella vulgata* at Nash Point (Dave Johnston, Natural Resources Wales. 15<sup>th</sup> Jan 2014).

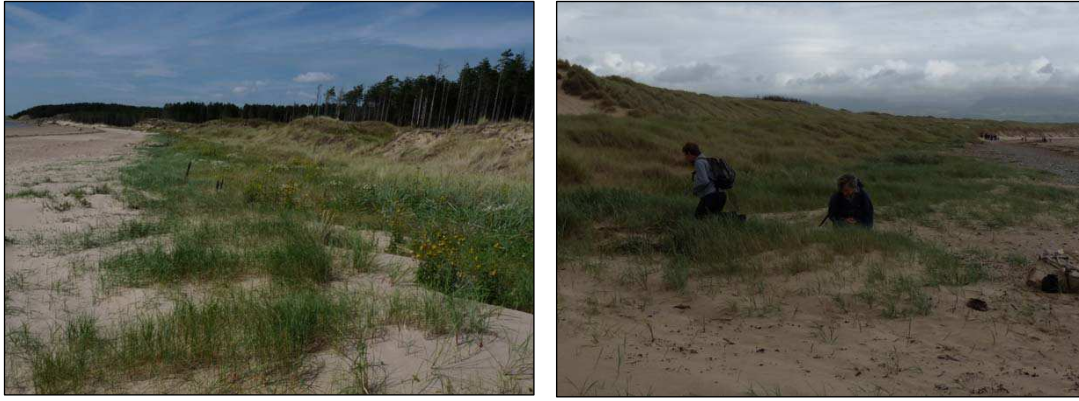
Figure 54. Sites at Newborough Warren supporting breeding populations of Sandhill Rustic in 2010 (see Wallace, 2011). These areas have been lost during the winter storm surges.

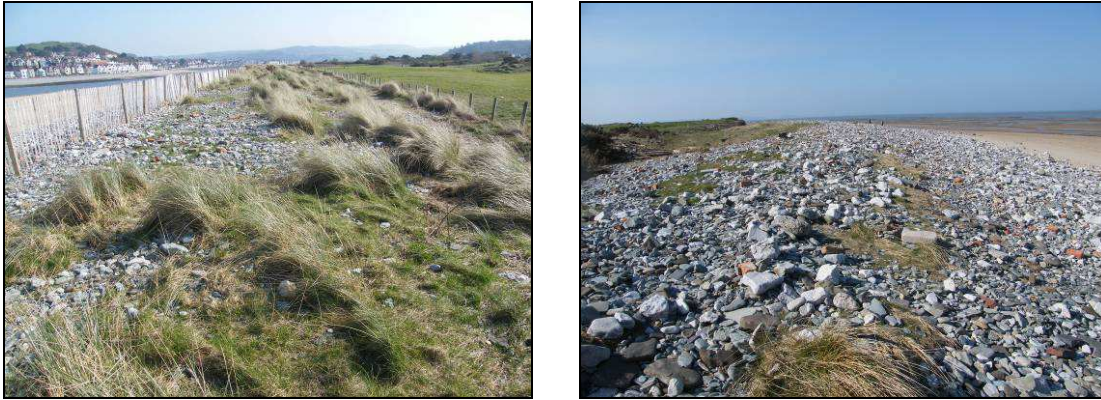
Figure 56. The loss of frontal dunes and deposition of cobble at Morfa Conwy, March 2014 (Mike Howe).

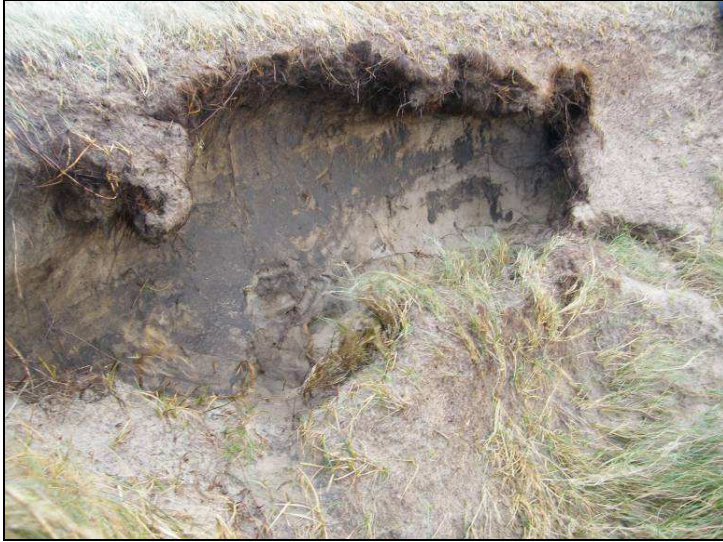
The collapse of a large section of the soft cliff at the western end of Porth Ceiriad this winter will have resulted in the loss of a large proportion of the population. At Porth Neigwl, the loss of large areas of forage on eroded cliff faces, the temporary loss of seepages and the near collapse of the main breeding locality (Figure 59) may have had a long-term impact upon the population. Surveys in summer 2014 have revealed that the bee has survived at both sites, although in reduced numbers with maximum counts of adult females of five and 20 at Porth Ceiriad and Porth Neigwl respectively (Carl Clee pers. comm.).

Figure 59. The further collapse of the main breeding area for the Large Mason Bee at Porth Neigwl. This small area (at the bottom of the picture) has supported more than 50% of the breeding females and is now precariously perched on the cliff top (Mike Howe).
