Aerial, Phase 1 and NVC Survey Llyn Tegid Reservoir Safety Project Bala, Gwynedd

Version 4

**Natural Resources Wales
Project CE0126**

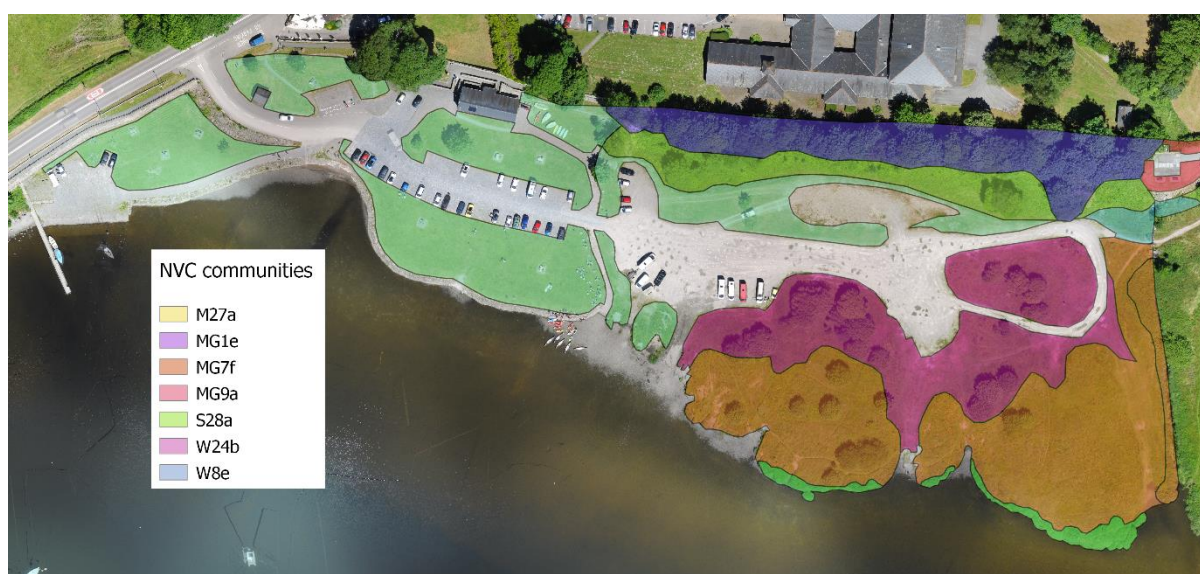
Figure 1 – National Vegetation Communities found in the car park area.

The car park area comprised six NVC sub-communities, excluding the woodland along the north, which is covered under Section 3.2.2, and the areas of tarmac and bare ground. The extent of these is summarised in Table 2 and mapped in Figure 1.

The largest area was covered by MG7f *Lolium perenne* leys and related grasslands, *Lolium perenne-Poa pratensis* grassland. This community covered the grassed areas around the car park. This is a community associated with amenity grassland and is of little conservation interest. In the middle of the car park area near the lake shore was an area that showed signs of heavily trampling and appeared to be transitioning to a more ruderal-rich OV NVC community (see Appendix C.2 0) but survey data suggested that this area was still closest to MG7f.

To the north of the car park and fringing the woodland along the embankment was a strip of scrubby grass that aligned closely with W24b *Rubus fruticosus-Holcus lanatus* underscrub, *Arrhenatherum elatius-Heracleum sphondylium* sub-community (see Appendix C.2 A). This was grassier than the described community and appeared to be an MG1e *Arrhenatherum elatius* grassland, *Centaurea nigra* sub-community in the latter stages of succession to W24b. This resulted in a higher frequency of Yorkshire-fog *Holcus lanatus*, lower frequency of Common Nettle *Urtica dioica* and the addition of Greater Bird's-foot-trefoil *Lotus pedunculatus*, Ribwort Plantain *Plantago lanceolata* and Common Sorrel *Rumex acetosa*. The presence of seedlings and saplings of Ash *Fraxinus excelsior*, Alder *Alnus glutinosa*, Sessile Oak *Quercus cf. petraea*, Downy Birch *Betula pubescens* and Goat Willow *Salix caprea* suggests that this area is likely to continue a successional path to woodland without intervention.

In the east of the car park area, south of the path leading east through the site, was a small area of MG1e *Arrhenatherum elatius* grassland, *Centaurea nigra* sub-community that had not started succeeding to woodland.

South of the eastern, unpaved part of the car park and the area surrounded by the dirt track was the third largest community that aligned most closely to MG9a *Holcus lanatus-Deschampsia cespitosa* grassland, *Poa trivialis* sub-community (see Appendix C.2 B). This wasn't a perfect match, due to a lower frequency of Tufted Hair-grass *Deschampsia cespitosa* than the described community and a higher proportion of fine rather than coarse grasses. Common Bent *Agrostis capillaris*, Red Fescue *Festuca rubra*, Ribwort Plantain *Plantago lanceolata* and Meadow Buttercup *Ranunculus acris* were all more frequent than in the described community.

Towards the south and east the MG9a community graded into a fen community. This aligned most closely to M27a *Filipendula ulmaria-Angelica sylvestris* mire, *Valeriana officinalis-Rumex acetosa* sub-community (see Appendix C.2 C). This stand was much more open than the described community, with Meadowsweet *Filipendula ulmaria* abundant but at a relatively low cover. This led to higher frequencies of False Oat-grass *Arrhenatherum elatius*, Tufted Hair-grass *Deschampsia caespitosa*, Ragged-Robin *Lychnis flos-cuculi*, Reed Canary-grass *Phalaris arundinacea* and Sneezewort *Achillea ptarmica* than the described community. The unusually high frequency of Reed Canary-grass, more prominent towards the lake shore in this instance, is mentioned by Rodwell (Rodwell 1991a) as occurring rarely within M27a stands. Bladder Sedge *Carex vesicaria* was found within this stand close to the lake shore, but only a few culms in one location. To the east, along the ditch, the vegetation became less open as is more typical of this community.

To the south of the M27a stand, along the lake shore, was a thin strip of S28a *Phalaris arundinacea* tall-herb fen, *Phalaris arundinacea* sub-community. This was clearly visible as dense Reed Canary-grass on the detailed aerial imagery and has been mapped, but was too thin to be readily surveyed in the field.

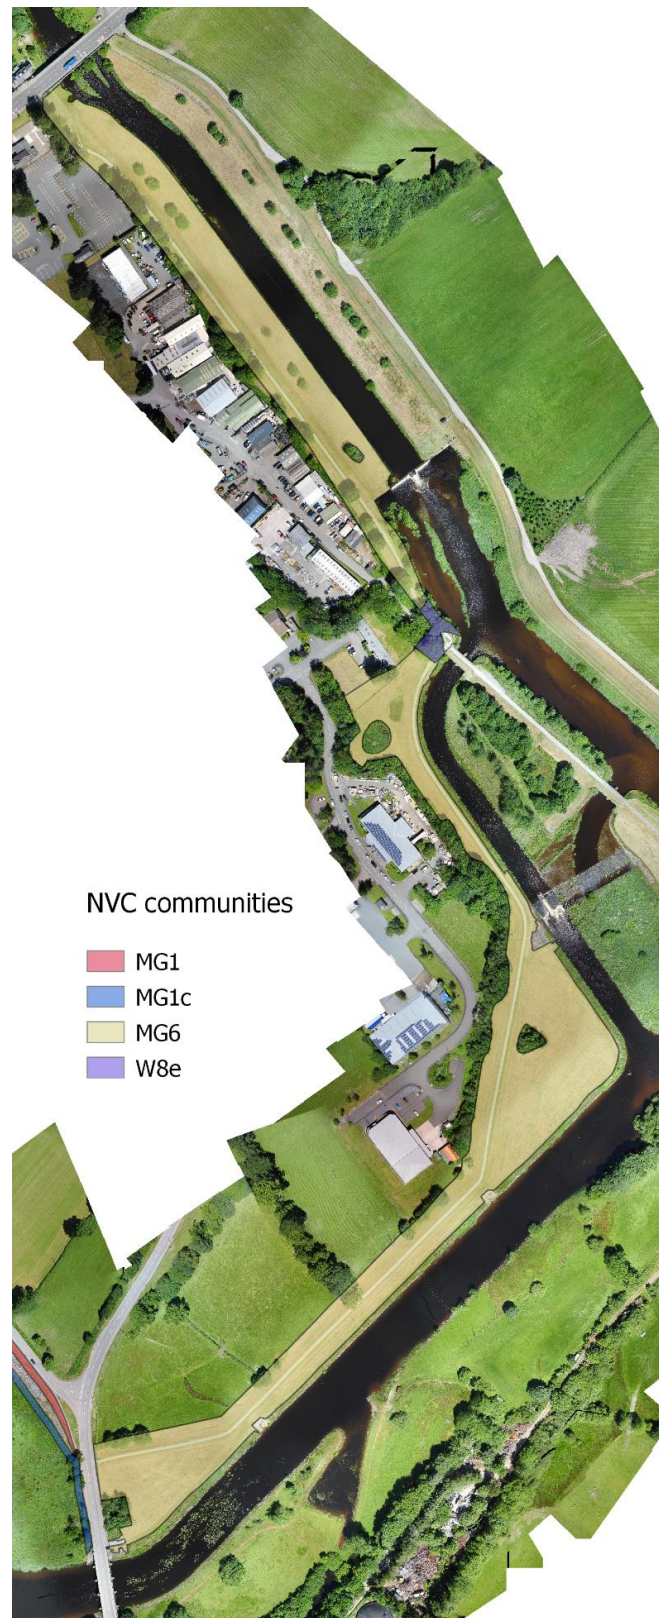
Figure 3 – National Vegetation Communities found in the river section of the embankments.

Almost all of the river section of the embankments was grassland, with a small patch of woodland at SH932358 (Figure 3).

As with the lake section, the grassland had been recently mown, though most of the arisings had been removed. Based upon the floristic diversity and the cut remains that

were left it was thought that this stand corresponded with MG6 *Lolium perenne-Cynosurus cristatus* grassland.

The small patch of woodland along the river section corresponded well with W8e *Fraxinus excelsior-Acer campestre-Mercurialis perennis* woodland, *Geranium robertianum* sub-community (see Appendix A target note 19).

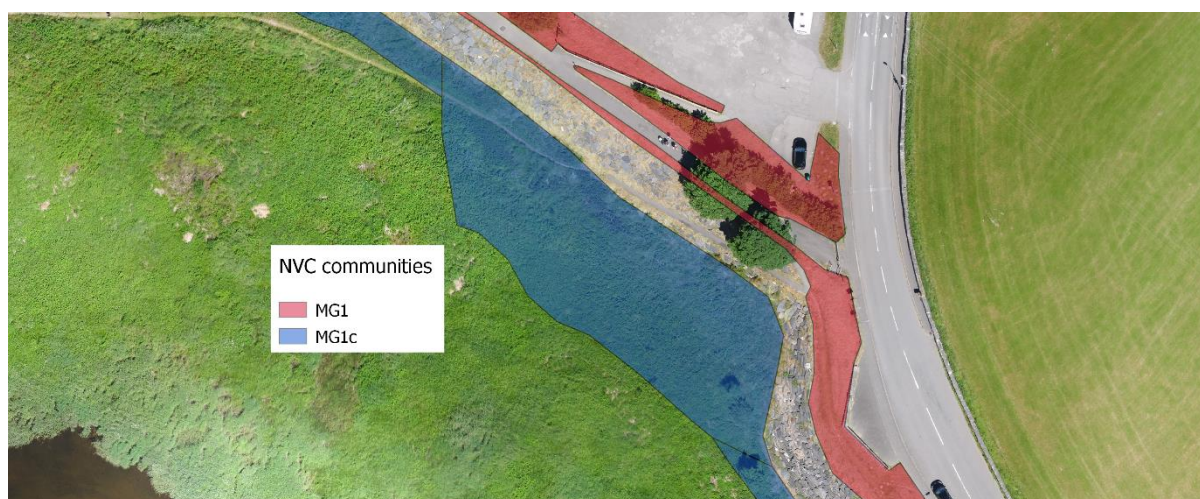
Figure 4 – National Vegetation Communities found in the bandstand area.

The bandstand area comprised a single stand that corresponded most closely with MG1c *Arrhenatherum elatius* grassland, *Filipendula ulmaria* sub-community. This stand was species poor compared with the described community, with Meadowsweet *Filipendula ulmaria* less frequent and Hogweed *Heracleum sphondylium* absent. In contrast, Hedge Bindweed *Calystegia sepium* was more prominent than the described community. The presence of Yellow Iris *Iris pseudacorus*, Reed Canary-grass *Phalaris arundinacea*, Marsh Woundwort *Stachys palustris* and Common Valerian *Valeriana officinalis* most likely reflected the composition of the nearby fen community. This stand extended beyond the area targeted for survey.
